Point No Point Estuary Restoration Groundwater & Surface Water

August 25, 2022

Overview

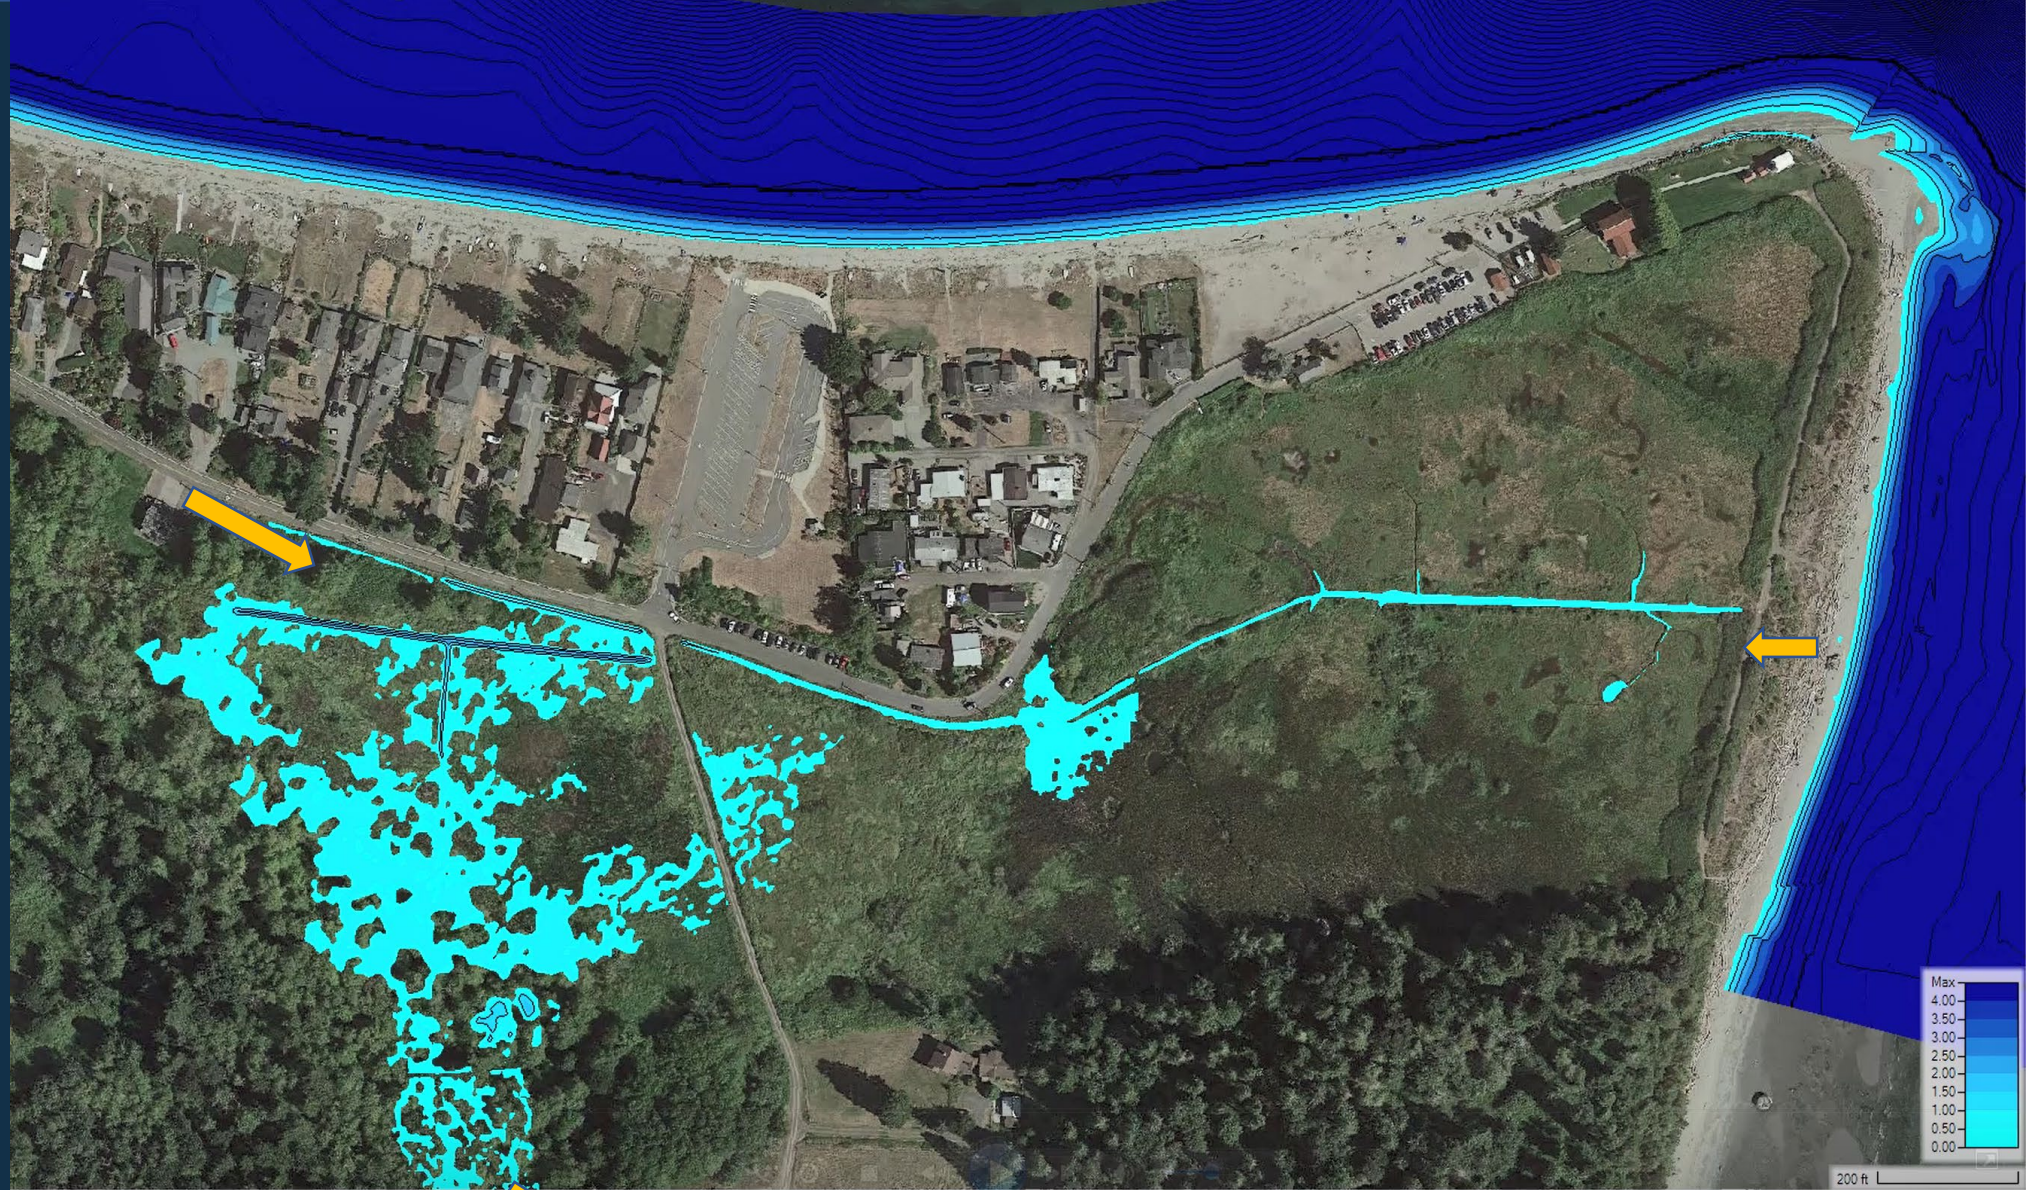
Existing Surface Water
Conditions
January 2, 2022
Before Heavy Rain

Inputs as yellow arrows

- Point No Point Creek and west drainage ditch flow inputs
- Tides through tide gate
- Internal culverts through Hillview Lane

Blue color represents water depth in feet

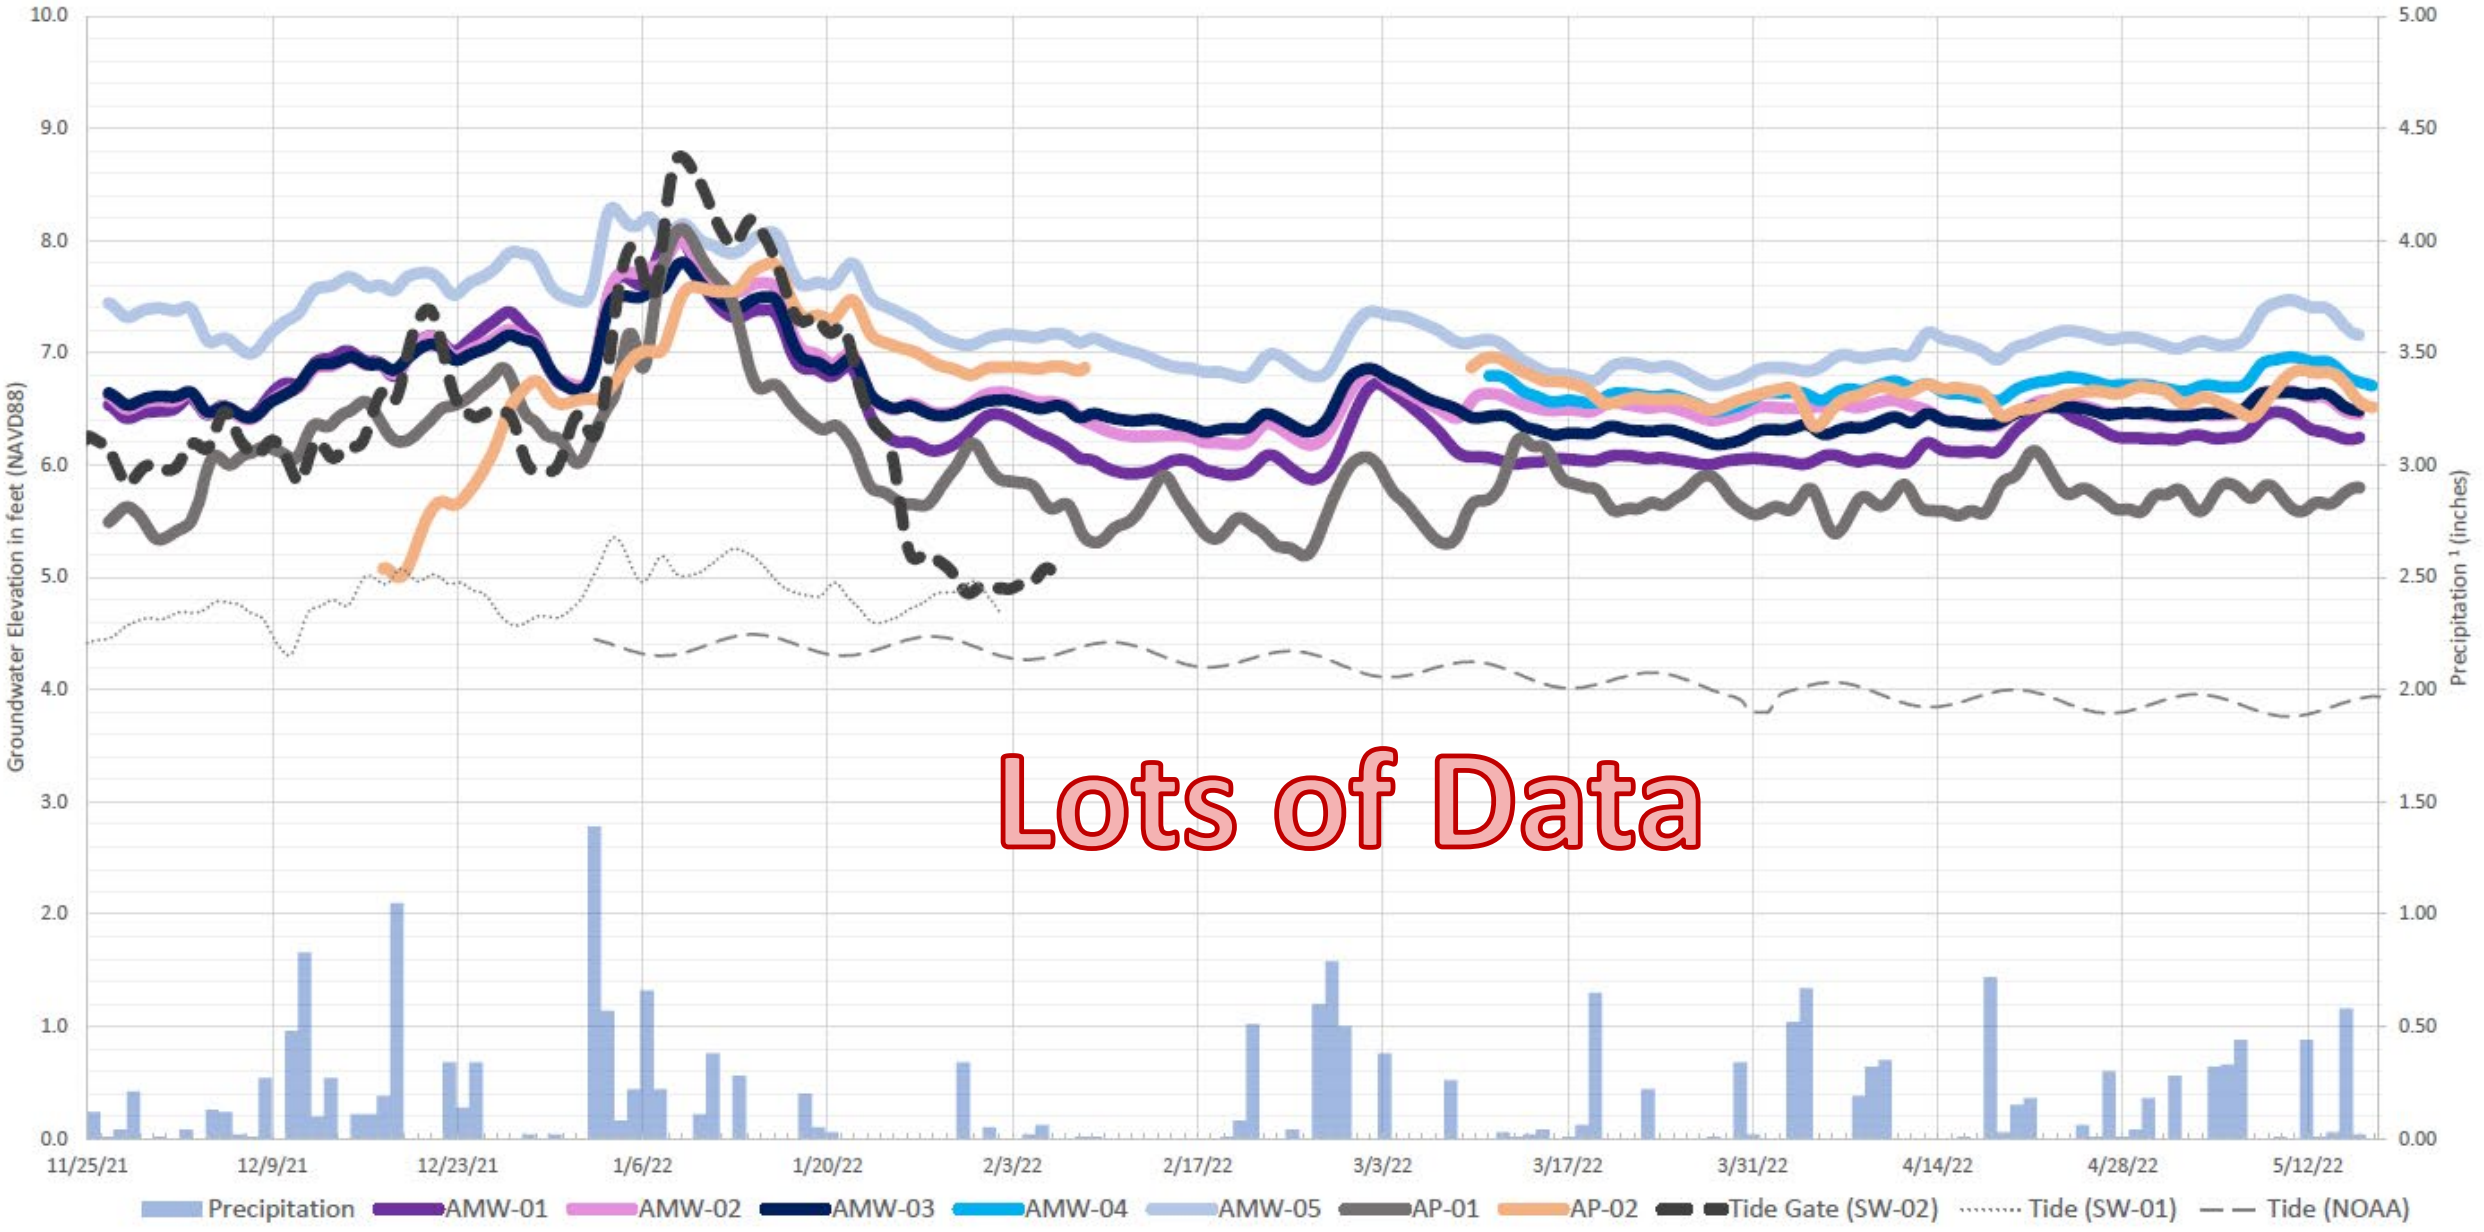
Note: (1) Precipitation data downloaded from Hansville Station - Kitsap Hydrologic Database by PUD #1 of Kitsap County from http://kpudhydrodata.kpud.org/APS FED_RAIN.aspx
 Tidal and Surface Water Data Sources: SW-01 (Blue Coast 11/22/2021 - 2/3/2022); SW-02 (Blue Coast 11/22/2021 - 2/7/2022); NOAA (Foul Wather Bluff Station 9445016 1/1/2022 - 5/31/2022)

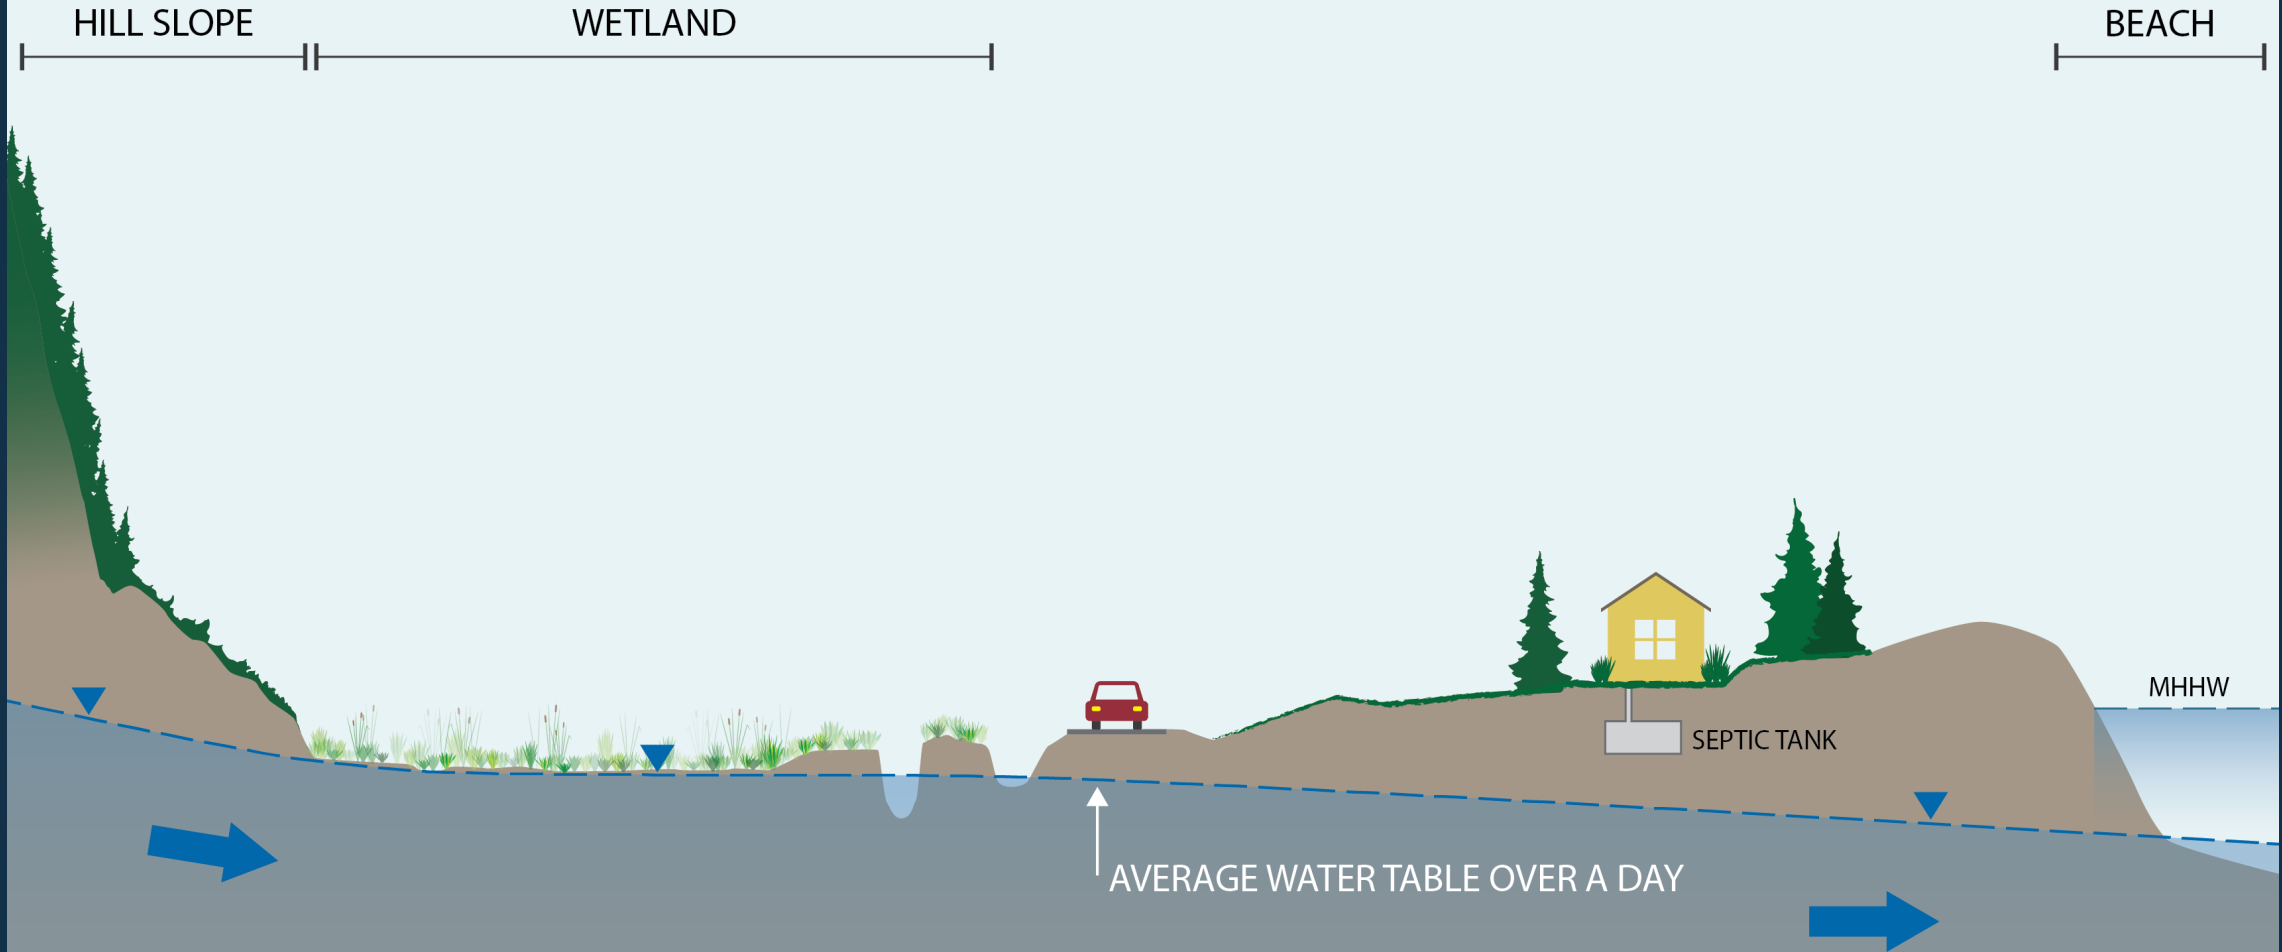
CURRENT CONDITIONS

Section View Conceptual Model of Ground Water

Under current conditions most of the channels in marsh were historically filled and the few remaining are blocked with invasive species so there is no capacity to infiltrate or convey ground water, so groundwater table is high and gets even higher during large rain events and fills stormwater ditches as route to try and drain towards Puget Sound.

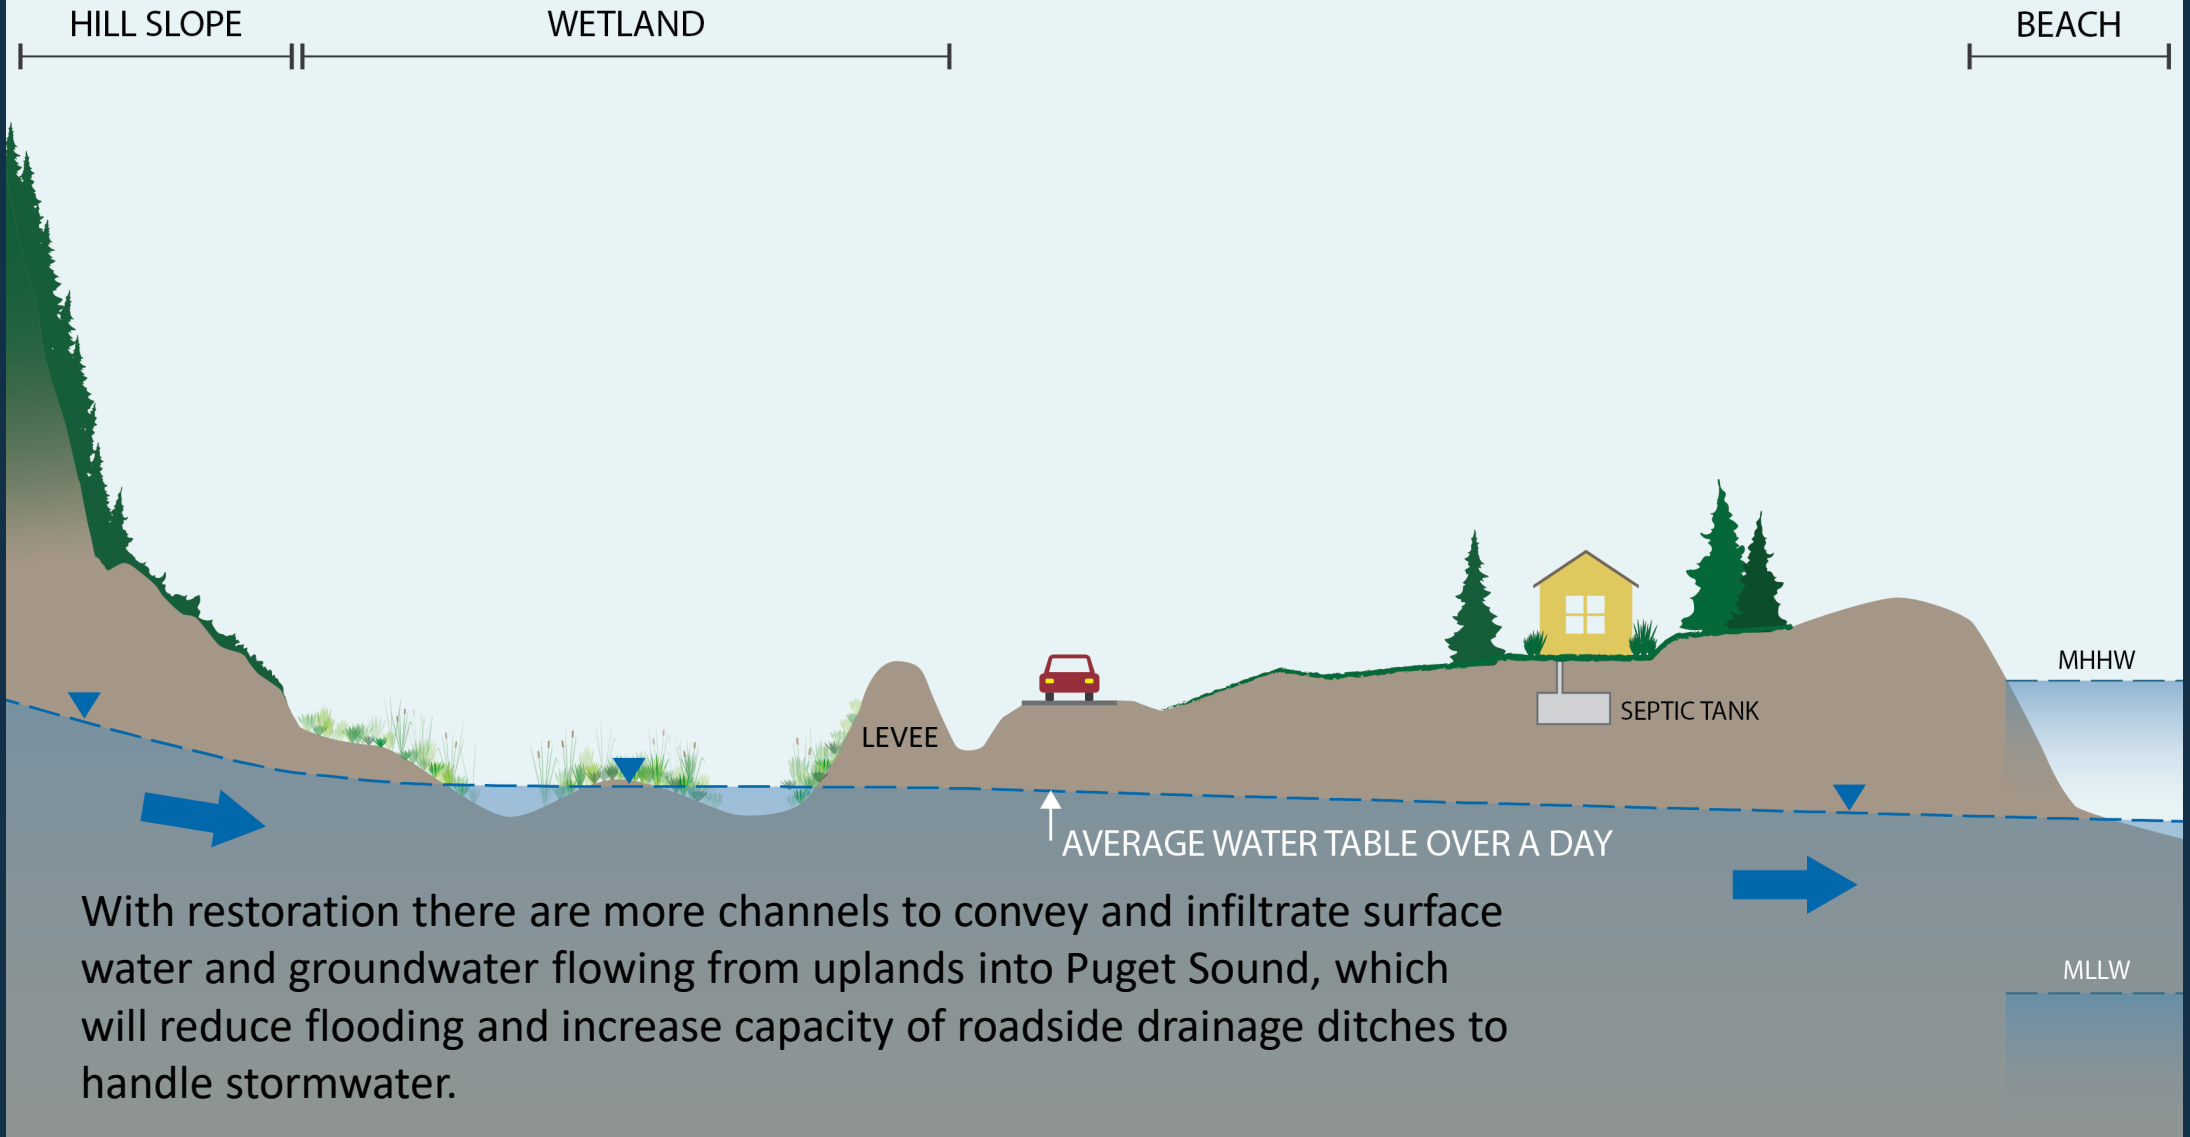
NEW WETLAND PROFILE

Section View Conceptual Model of Possible Future Ground Water

With restoration there are more channels to convey and infiltrate surface water and groundwater flowing from uplands into Puget Sound, which will reduce flooding and increase capacity of roadside drainage ditches to handle stormwater.

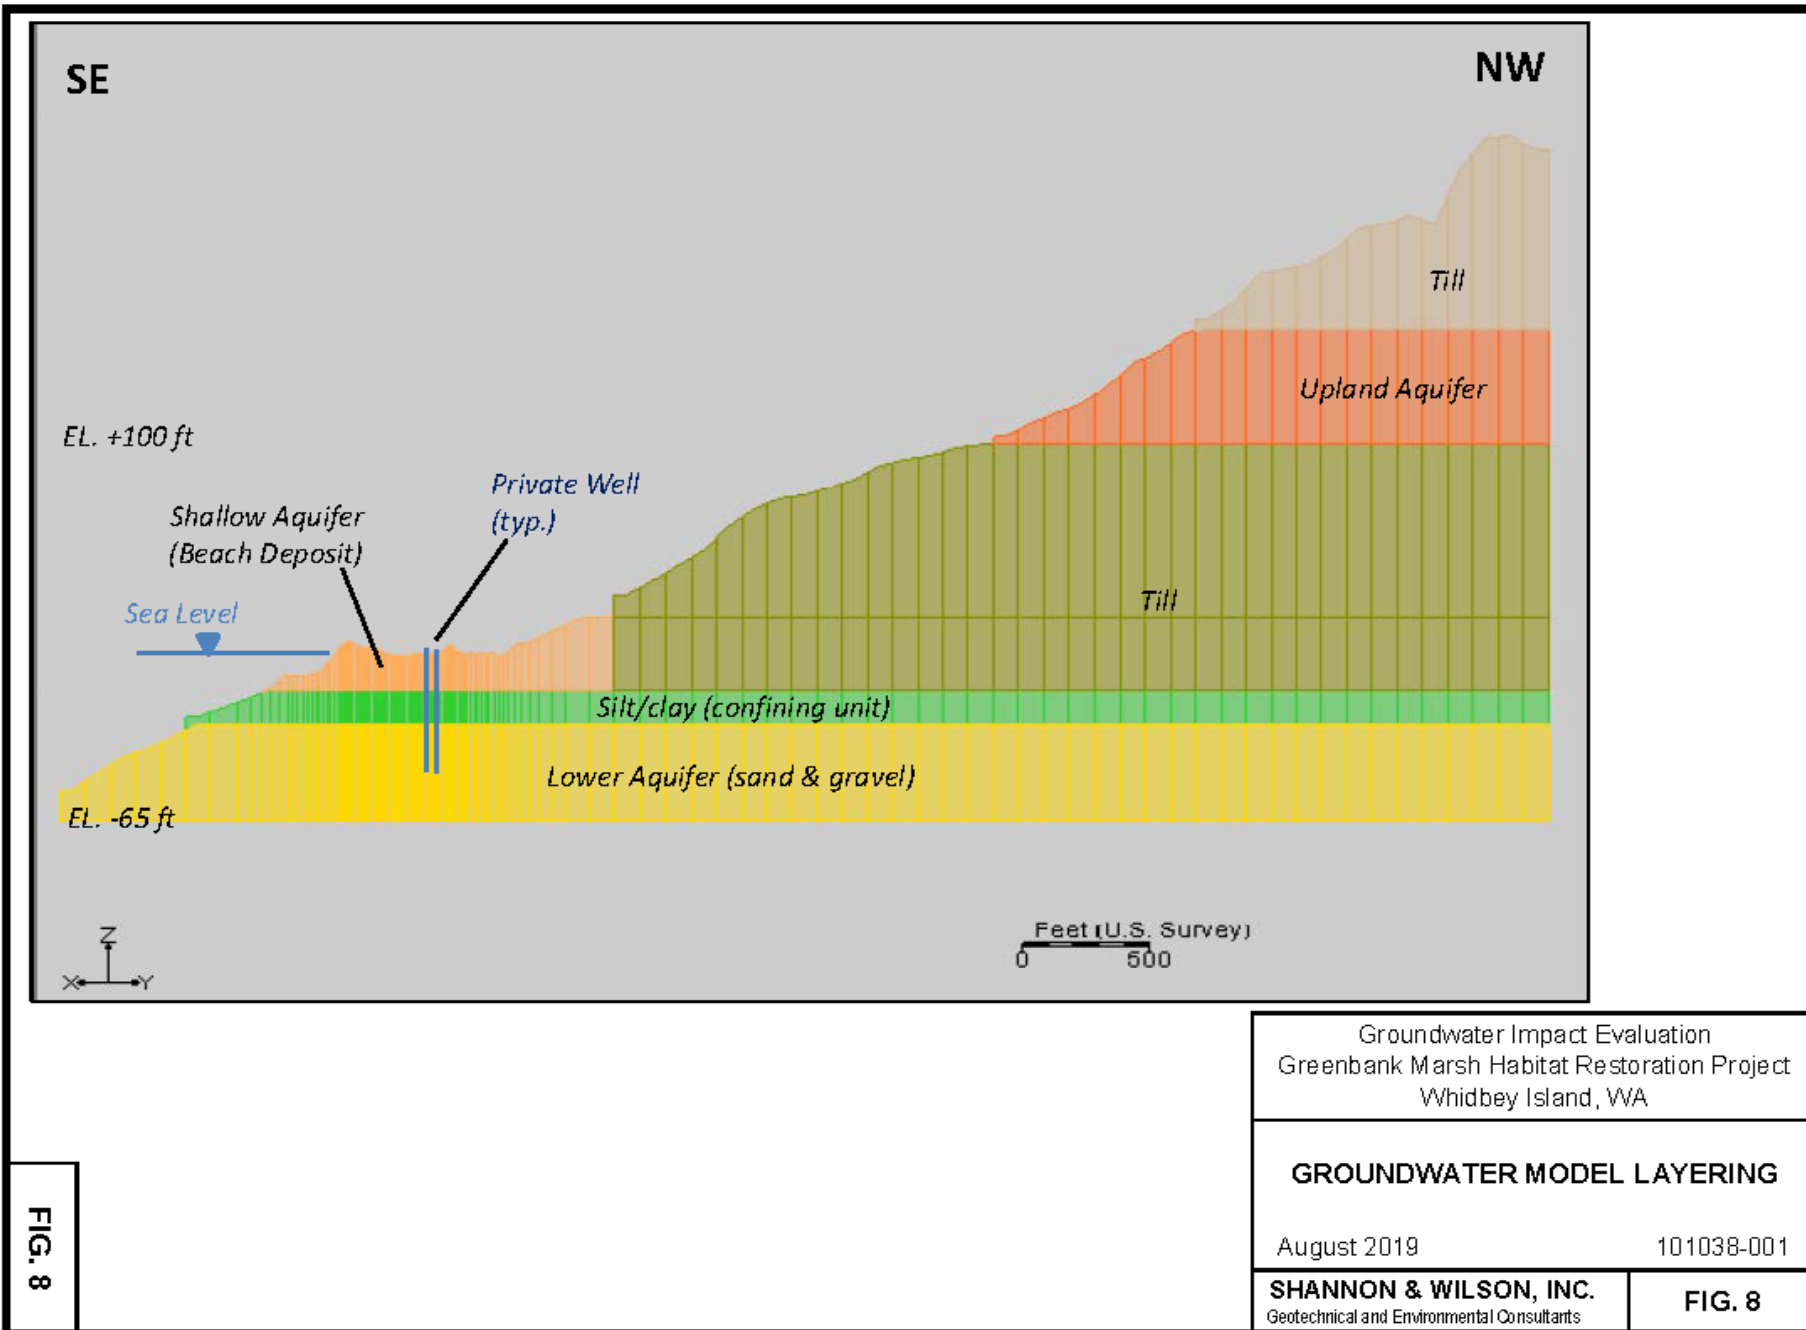
FIG. 8

Greenbank Groundwater Model Section

GROUNDWATER MODEL LAYERING
August 2019 101038-001
