Point No Point Estuary Restoration King Tide Events

February 9, 2023

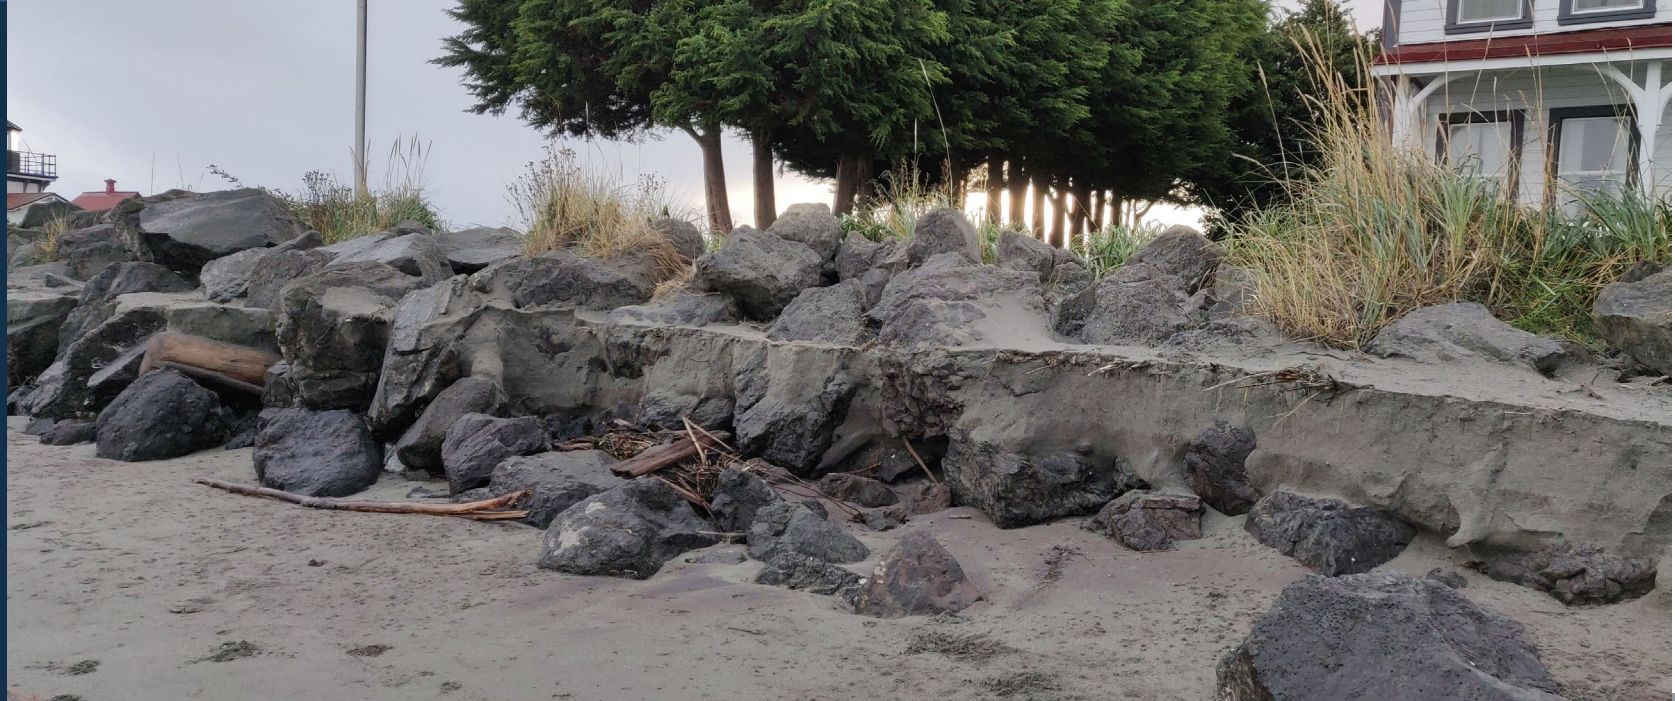
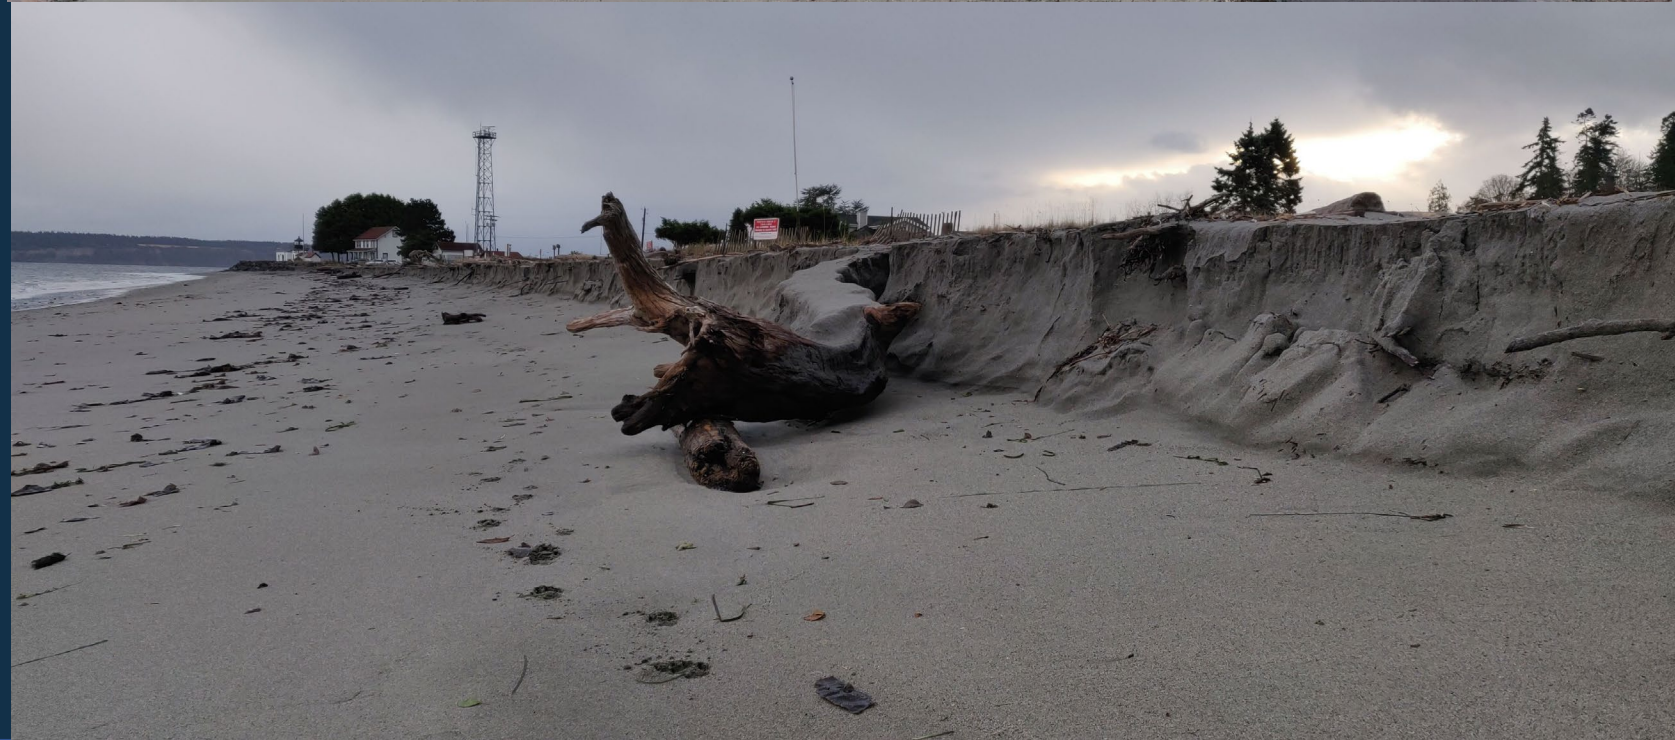
November 5, 2022

Erosion

Wind speed: 26 knots (30 mph)

Wind Direction: Northwest @ Point
No Point

Estimated Wave Height = 3 feet

Wave Period = 4.1 seconds

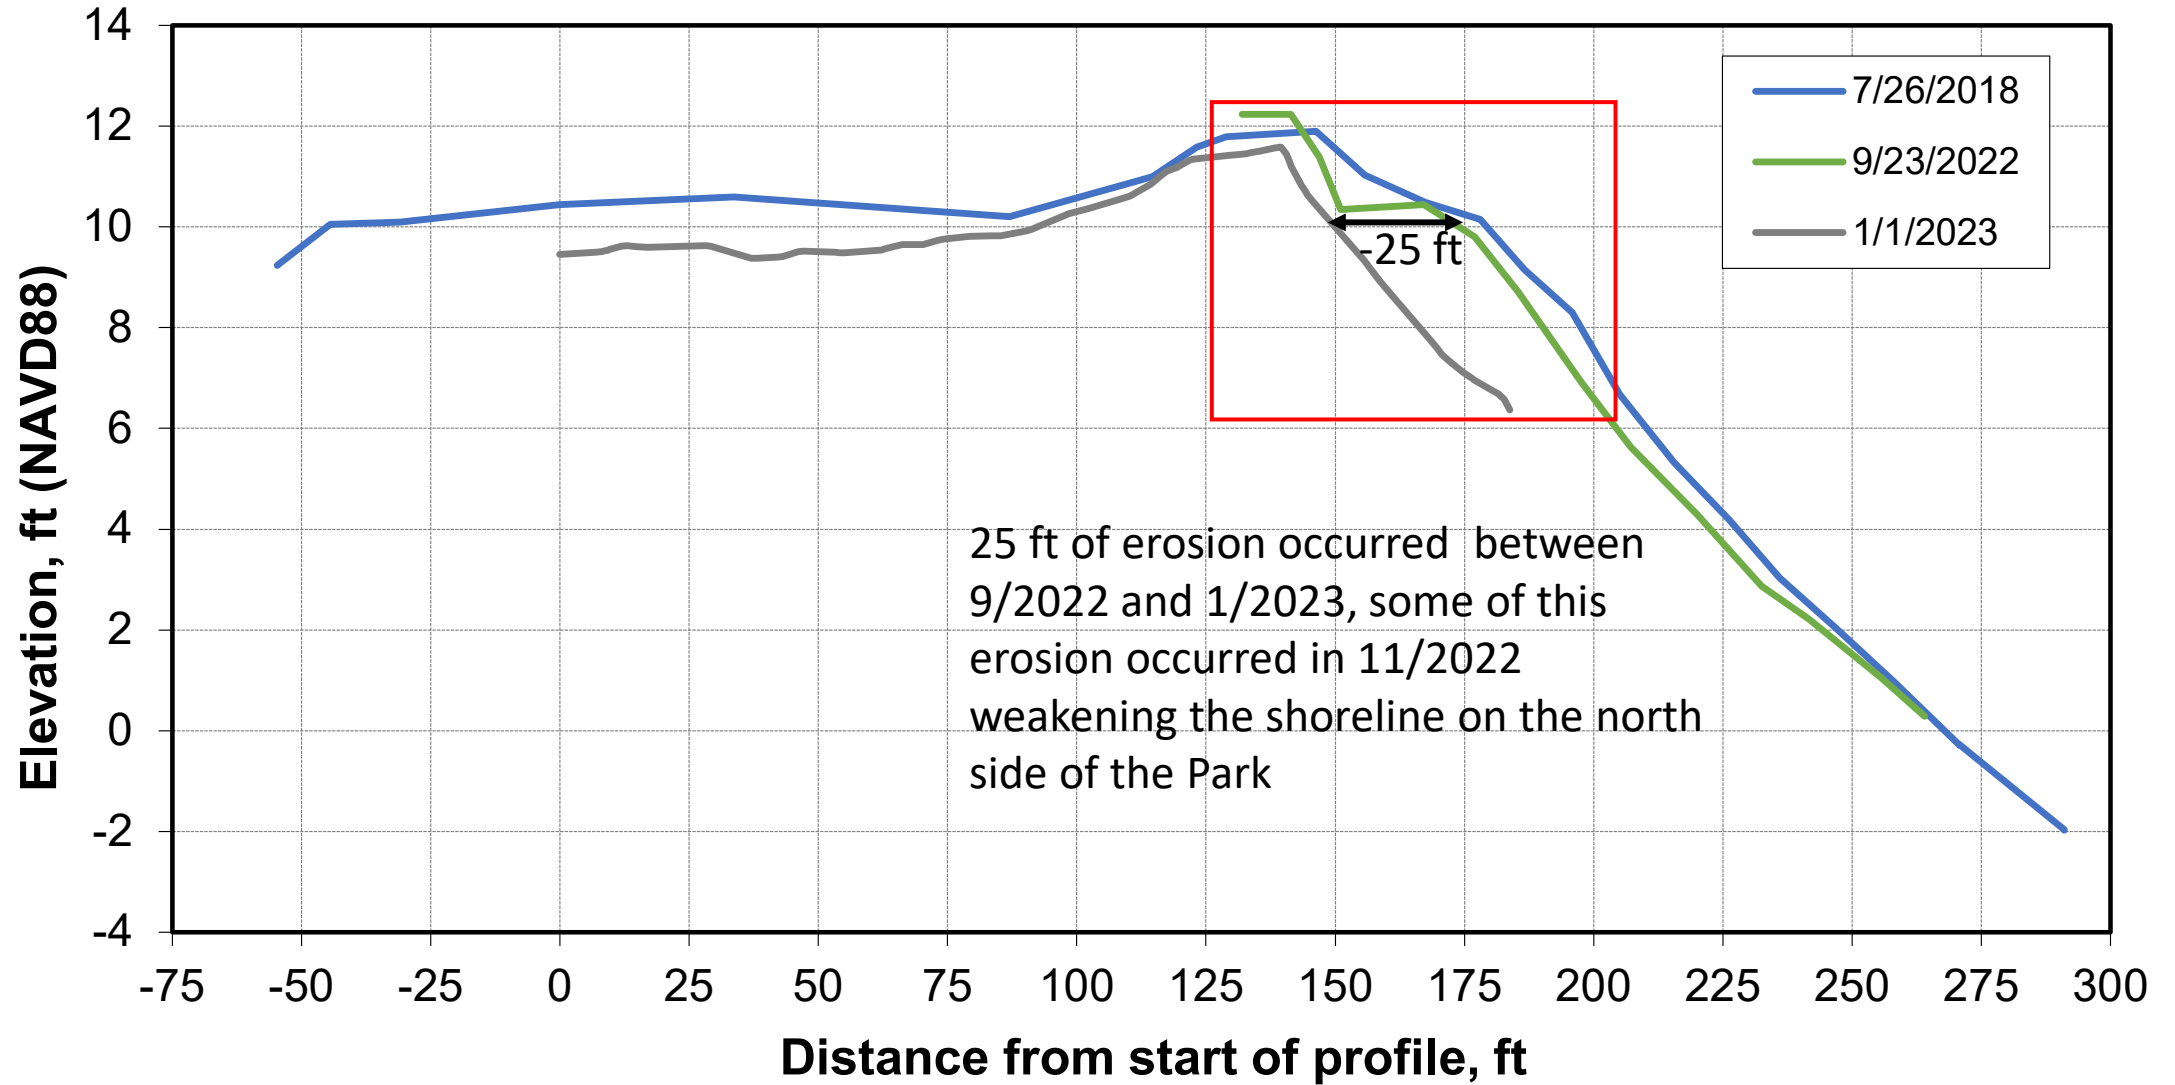
Cross Shore Beach Profile Change Analysis TX 1 Western Boundary of the Park

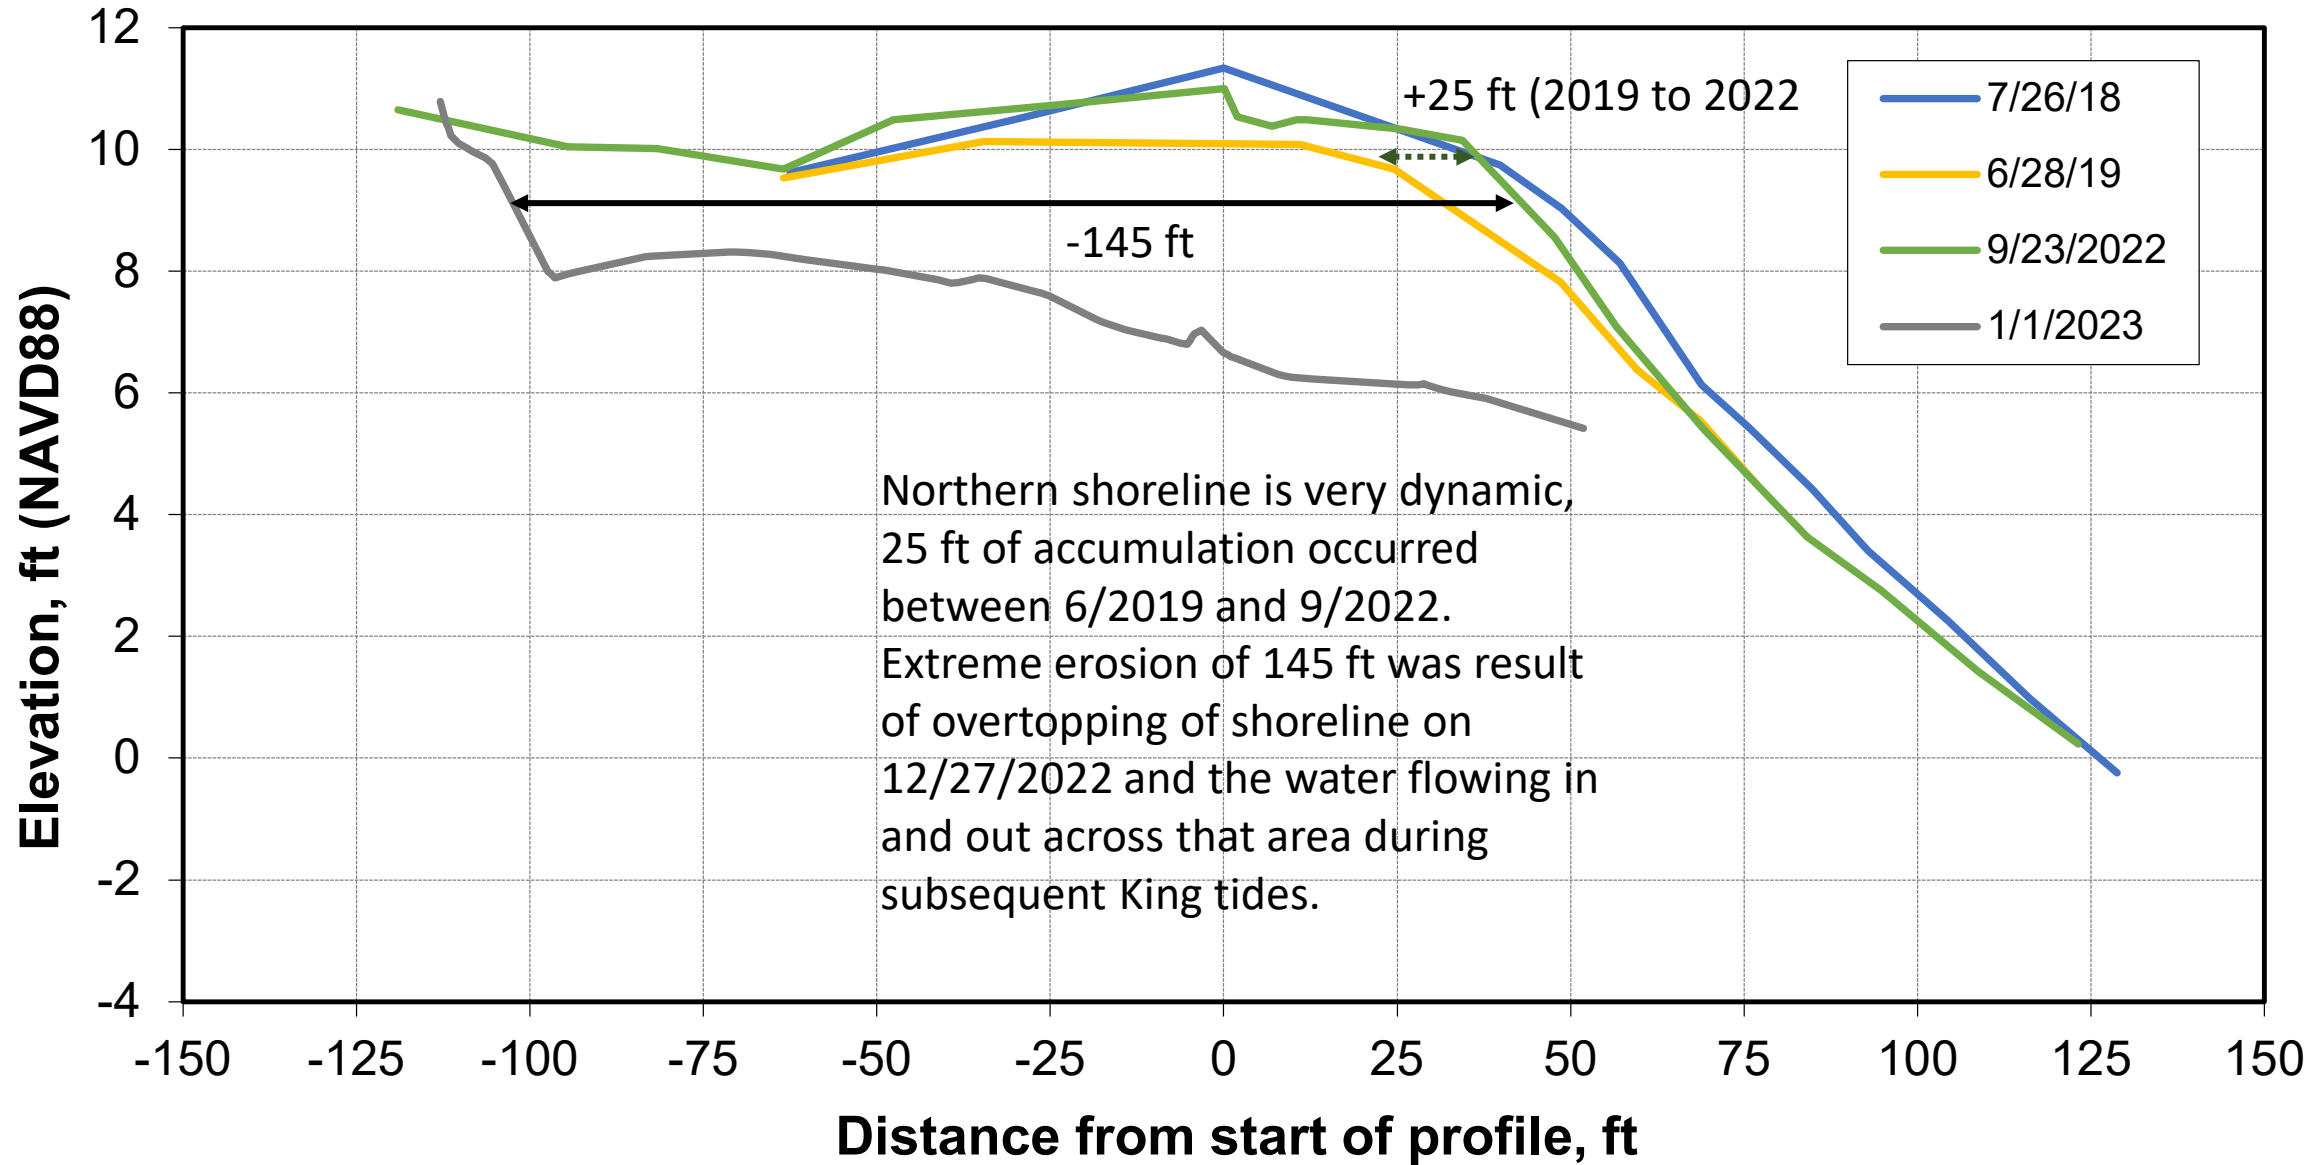
Cross Shore Beach Profile Change Analysis TX 3 Middle of Northern Beach

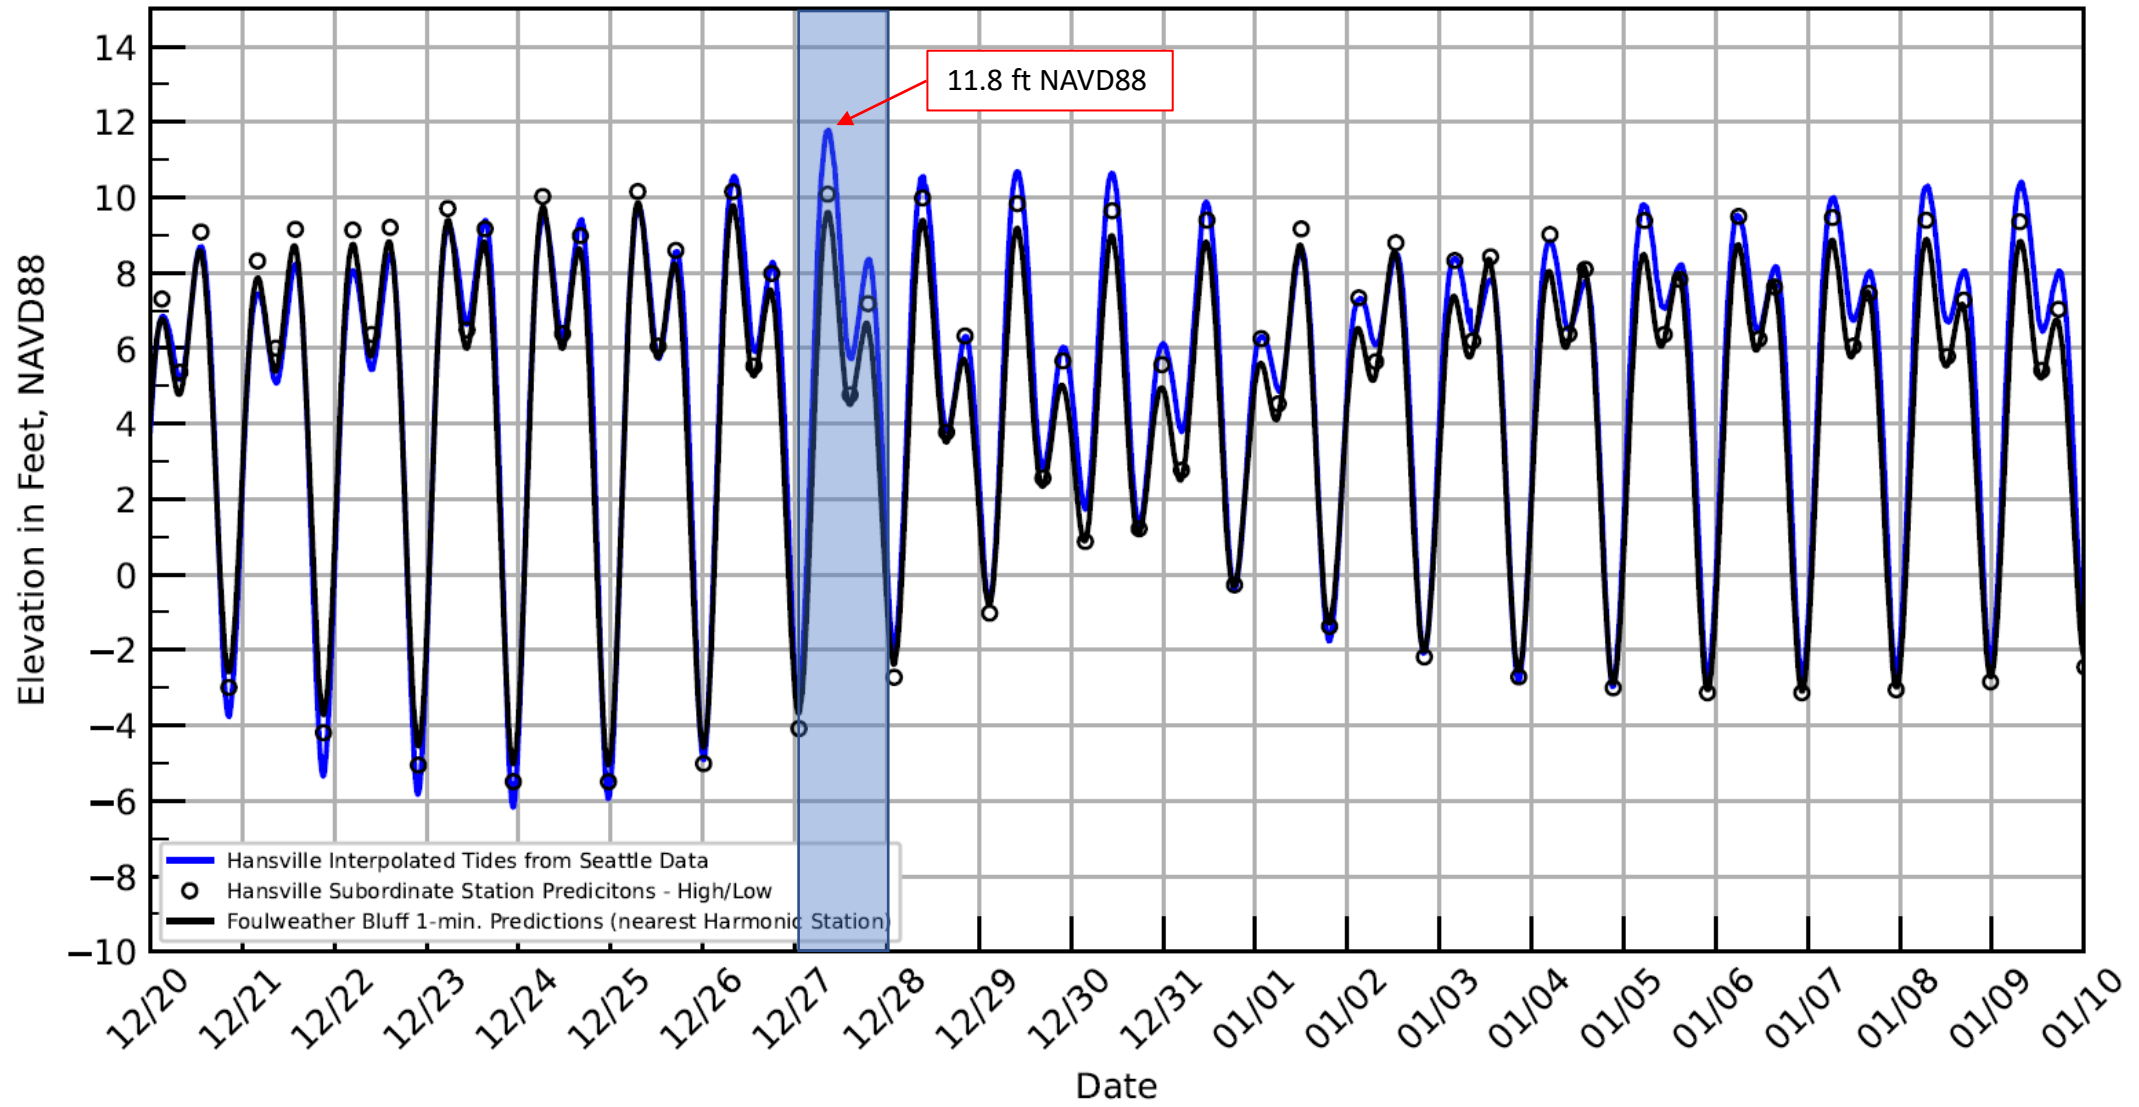
Hansville NOAA Station - Interpolated Tidal Signal From Seattle Data

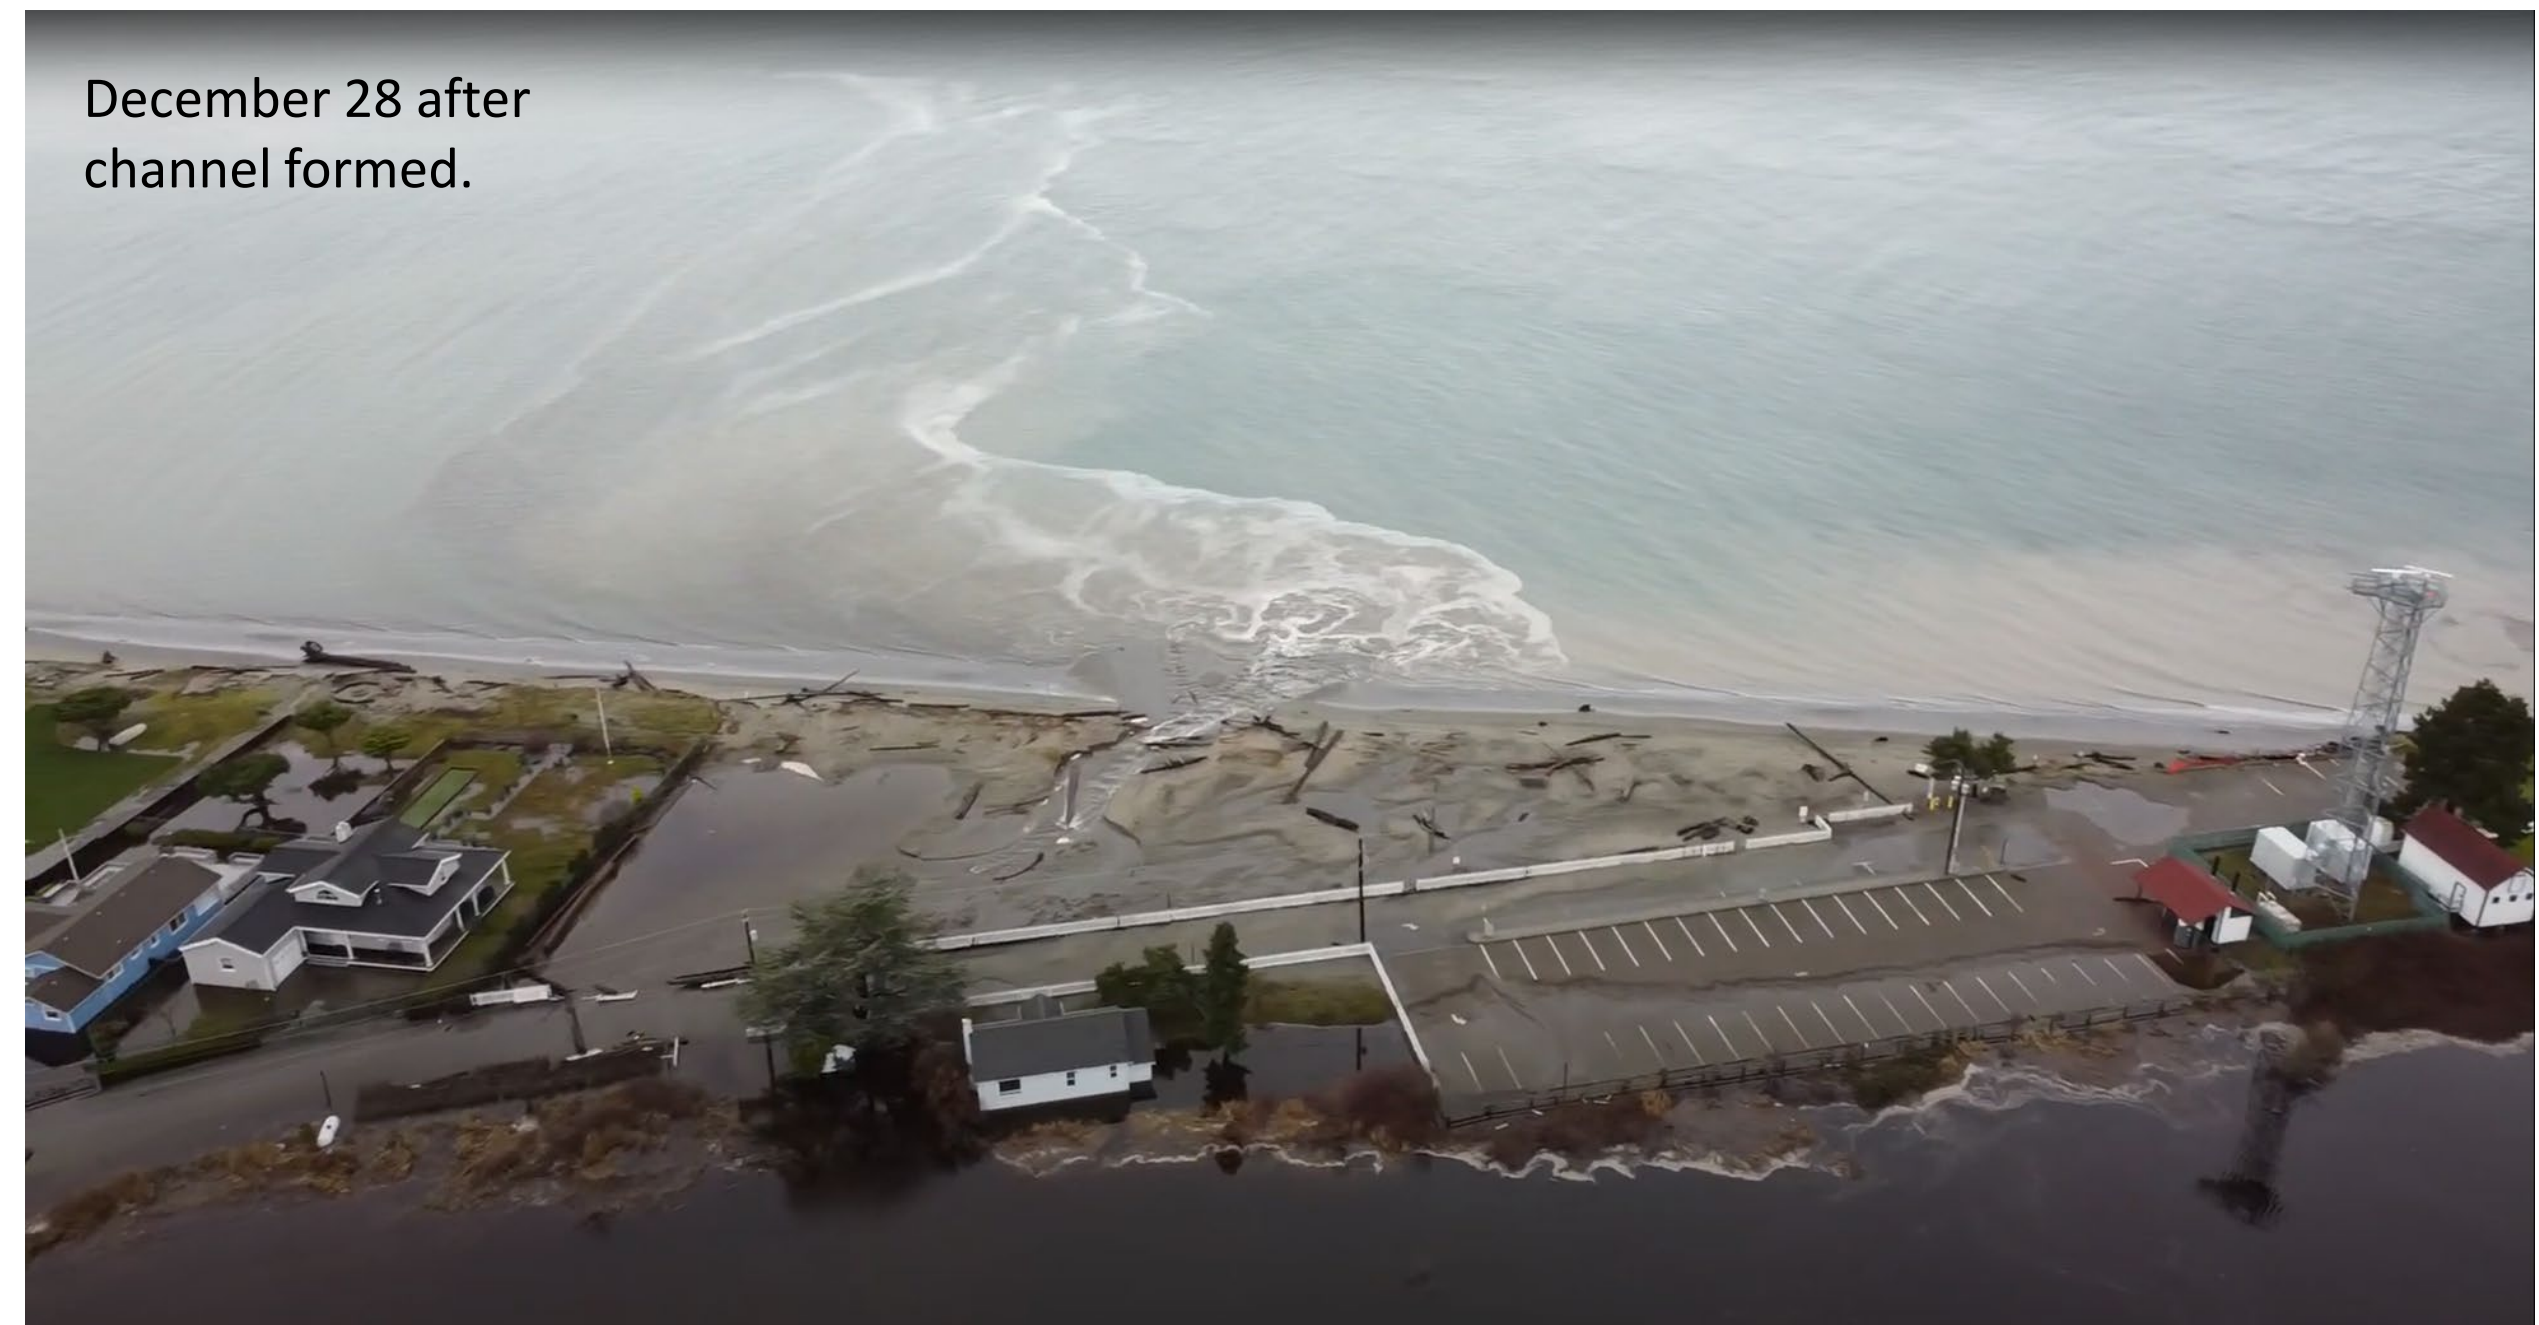
December 28 after
channel formed.

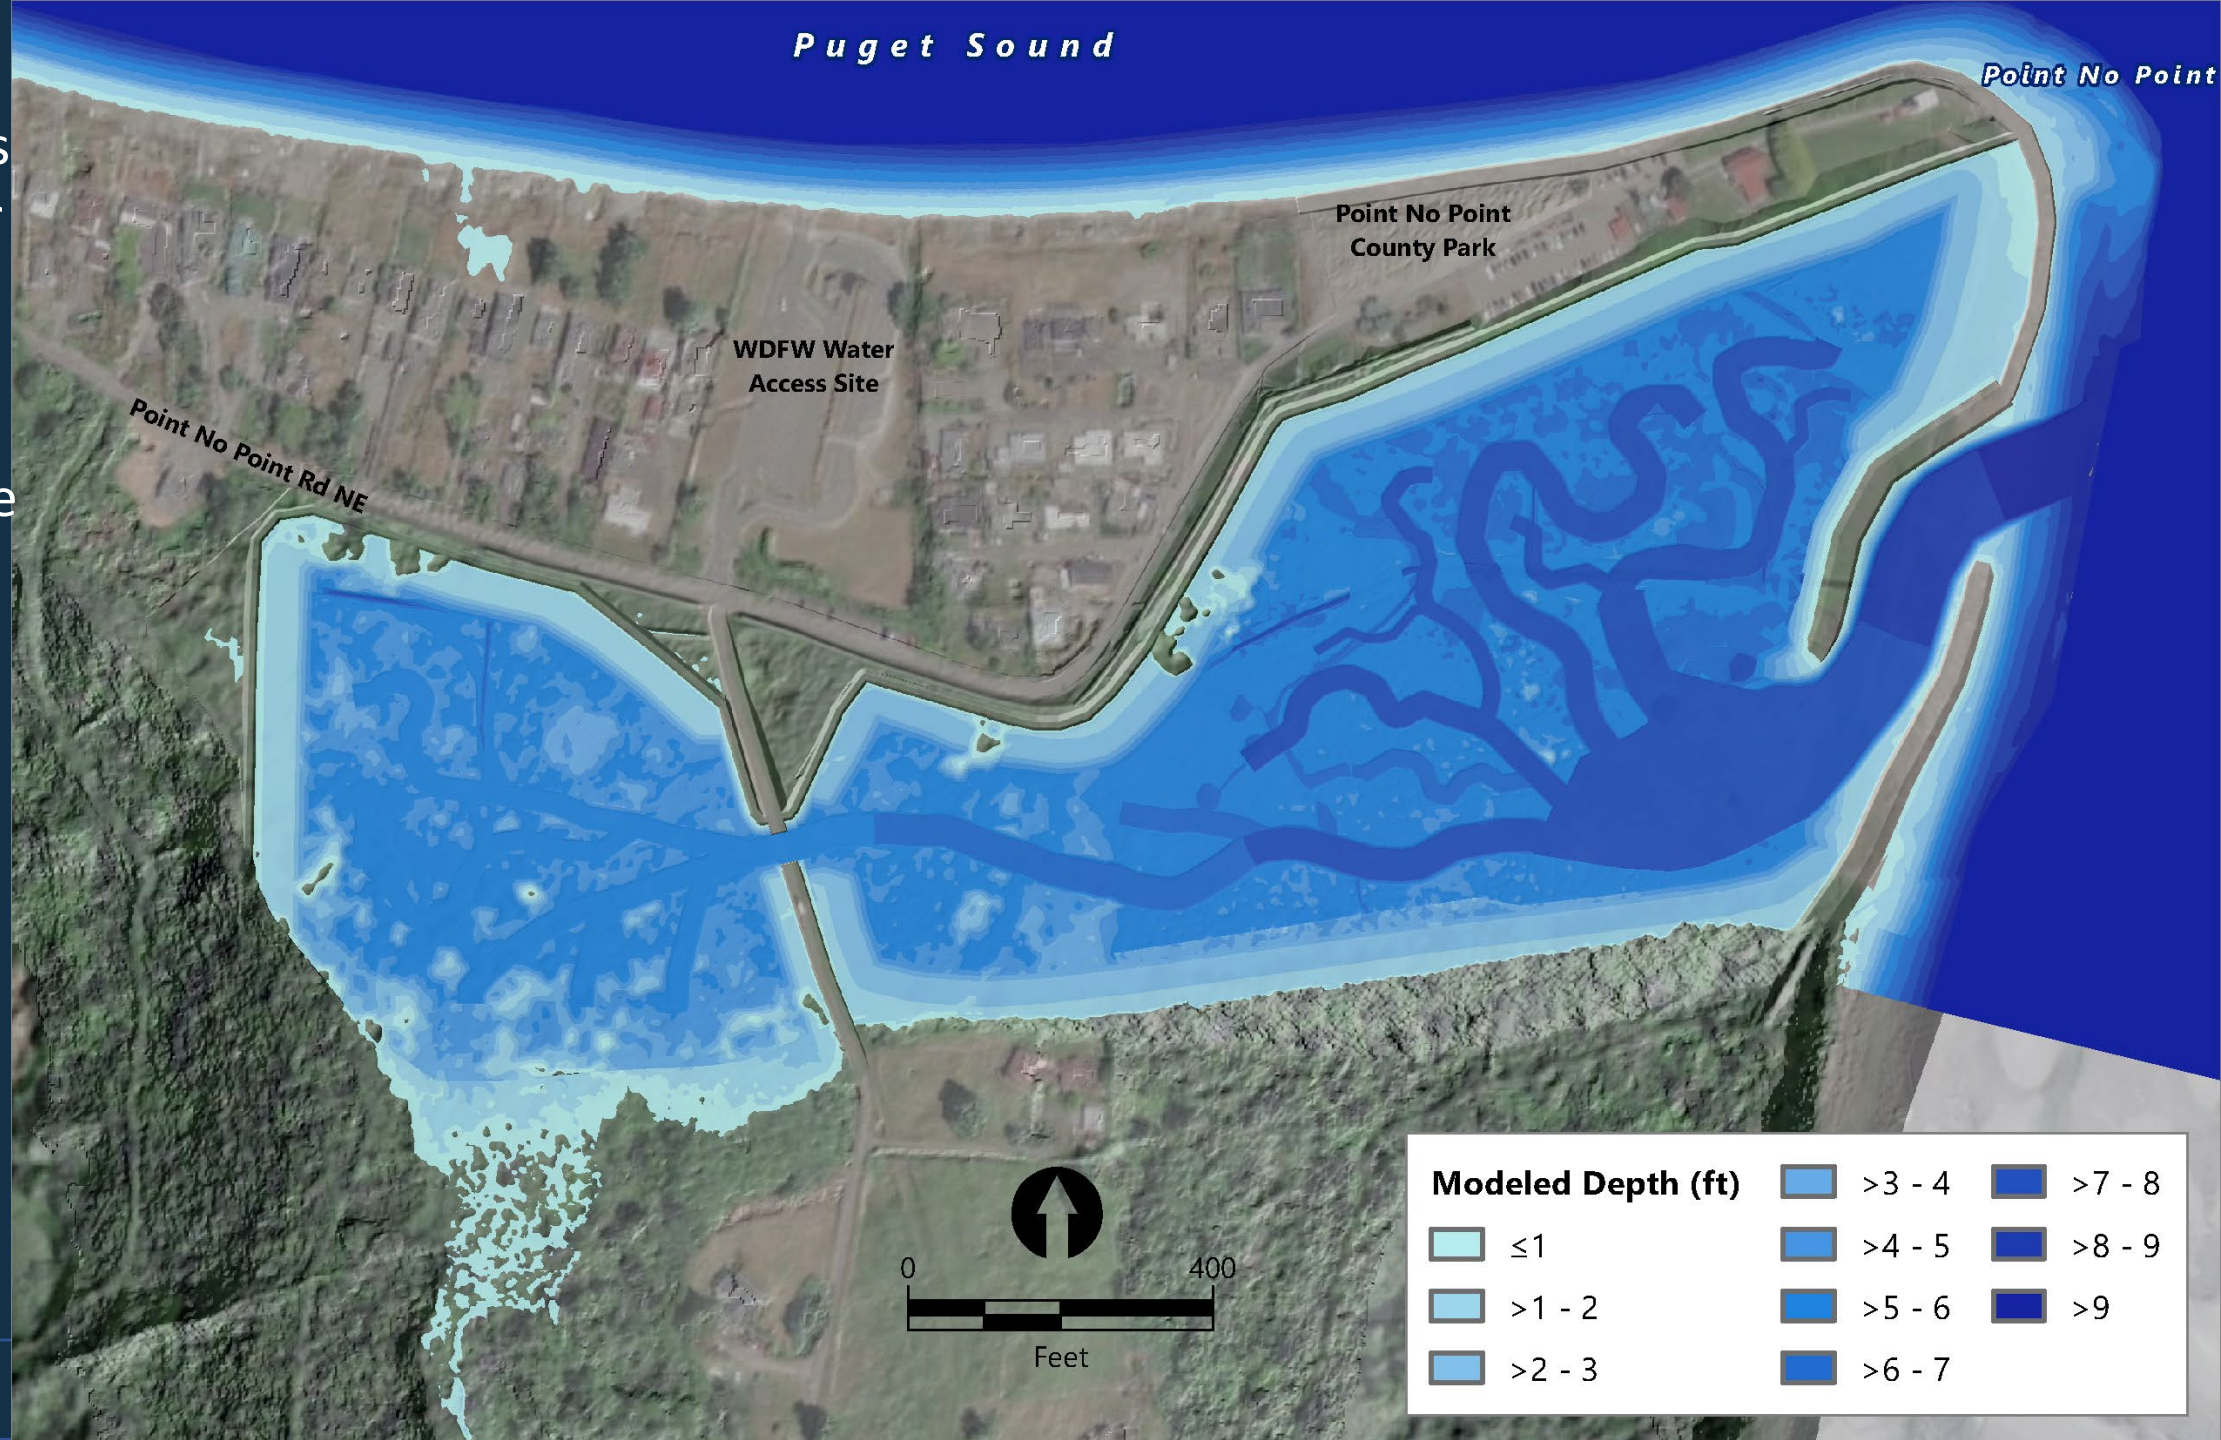
Water Depths on December 28 King Tide Event If Full Restoration Scenario were implemented
