COTTAGE LAKE CREEK WEIR REMOVAL PROJECT

MID PUGET SOUND FISHERIES ENHANCEMENT GROUP

July 18, 2023

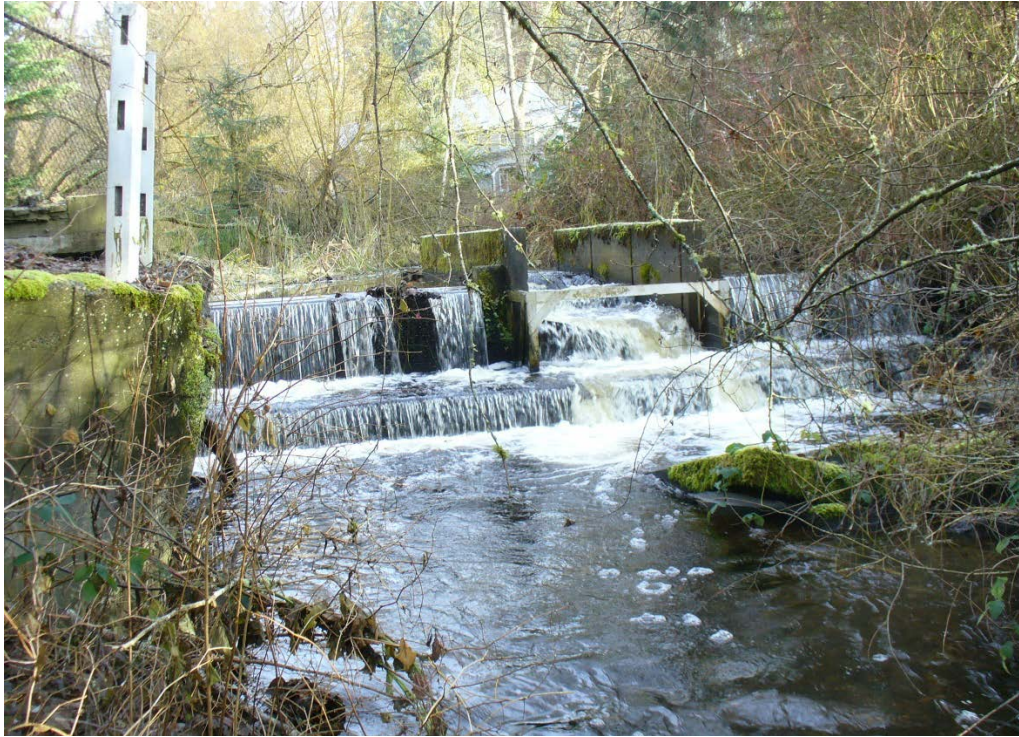
Figure 9. Existing weir and fish ladder (12/15/22).

The weir is approximately 30 ft wide and 5 ft tall with a fish ladder including wood slats with pools. The retaining walls on either side are 7 ft high and 15 ft long. In the channel at the base of the weir is a concrete slab which formerly functioned as a footbridge support, but which fell into the creek when the footbridge failed in the 1990's (see photos, Figures 17 and 18, below). The former bridge footings and abutments which are still standing along either bank are beginning to fail and tilt over the stream.

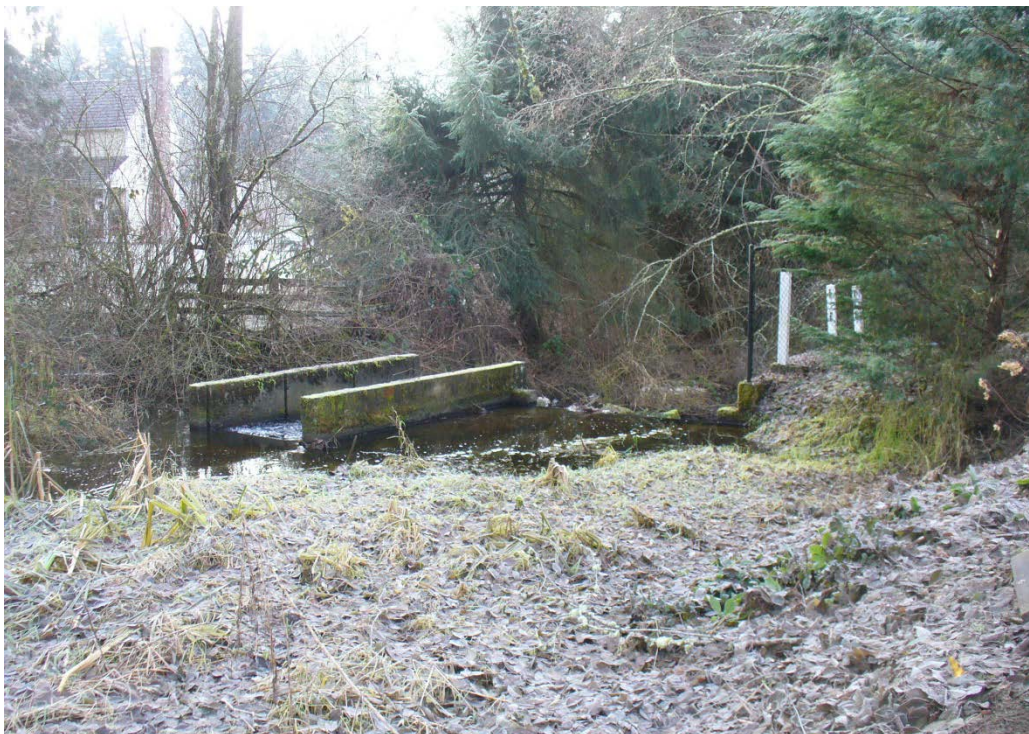
Figure 12. Facing southeast downstream from above the weir. Riverine wetland in foreground, fish ladder walls and weir in the center, a home in Homestead neighborhood is in the background, upper left. (1/17/23).

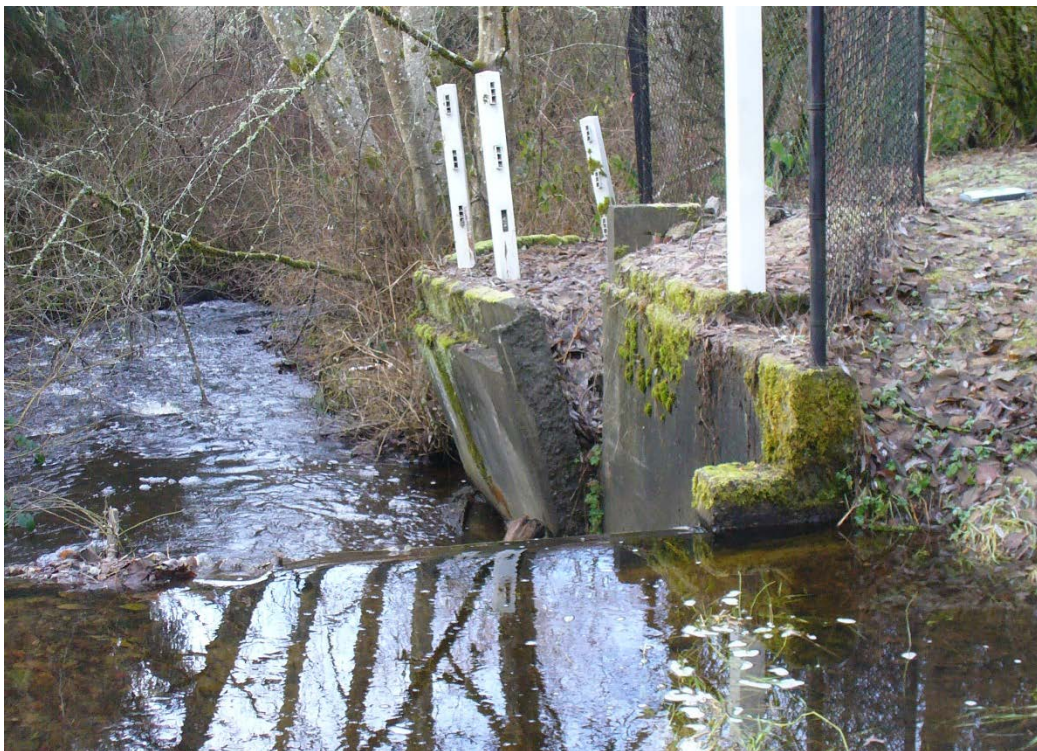
Figure 16. Facing downstream (south) from just above the weir. Note failing concrete wall which was a former footbridge abutment (12/15/22).

The weir was originally built as an irrigation water diversion structure for agriculture, but it currently serves no function. The weir complex is a concrete structure with concrete weirs, concrete streambank retaining walls, and a timber weir-pool fishway. Downstream of the concrete weir, the retaining walls on both sides have been undermined and have active flow under and behind them, and they are starting to fail. See the photo figures below for various views of the weir and access routes; see Figures 16 and 18 for views of the failing retaining walls.

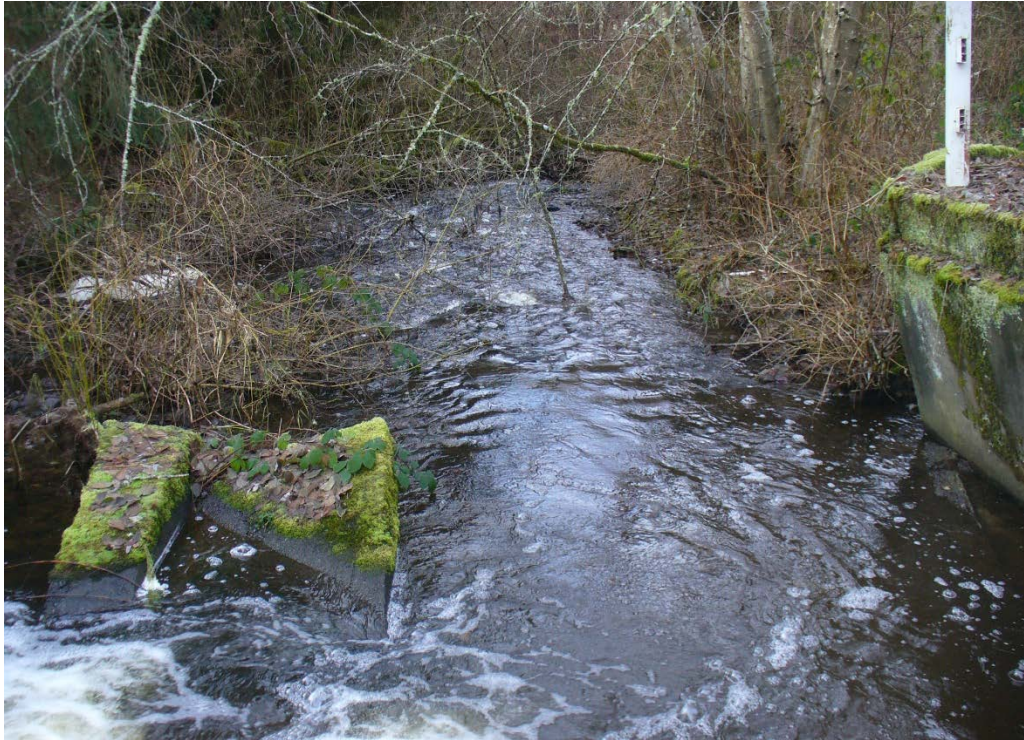
Figure 17. A view of the channel facing south, downstream. The concrete in the channel on the left side is a toppled center support for the former footbridge (12/15/22).

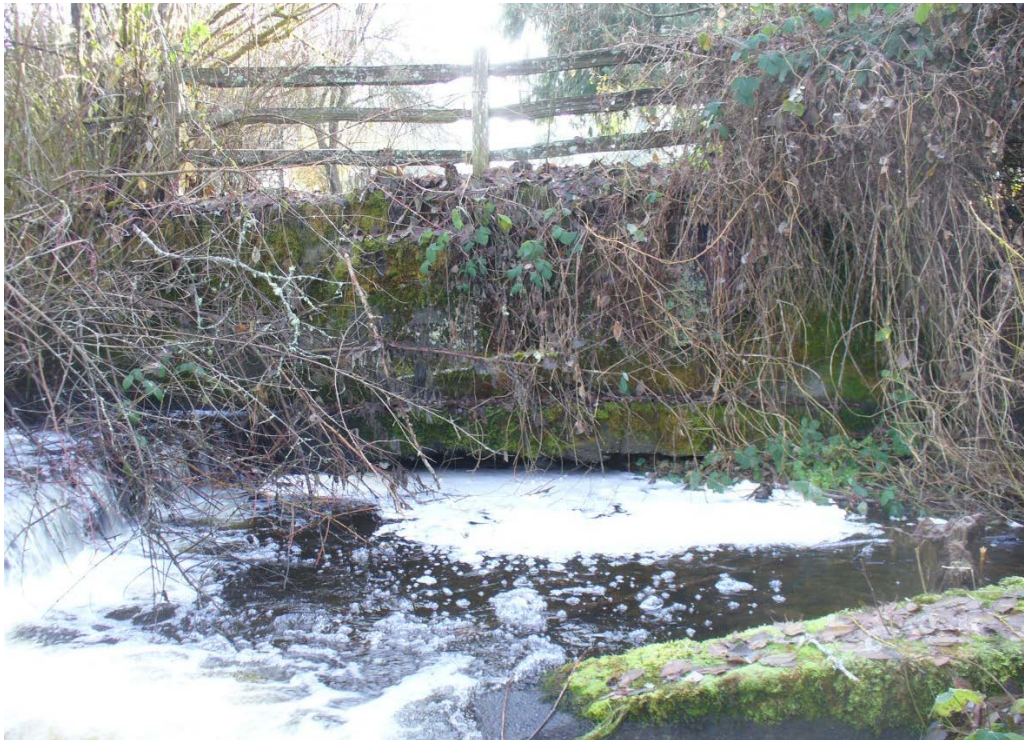
Figure 18. Facing east, vertical streambank just below the weir, beyond which is the Homestead community (12/15/22). Note undercut, failing support wall.

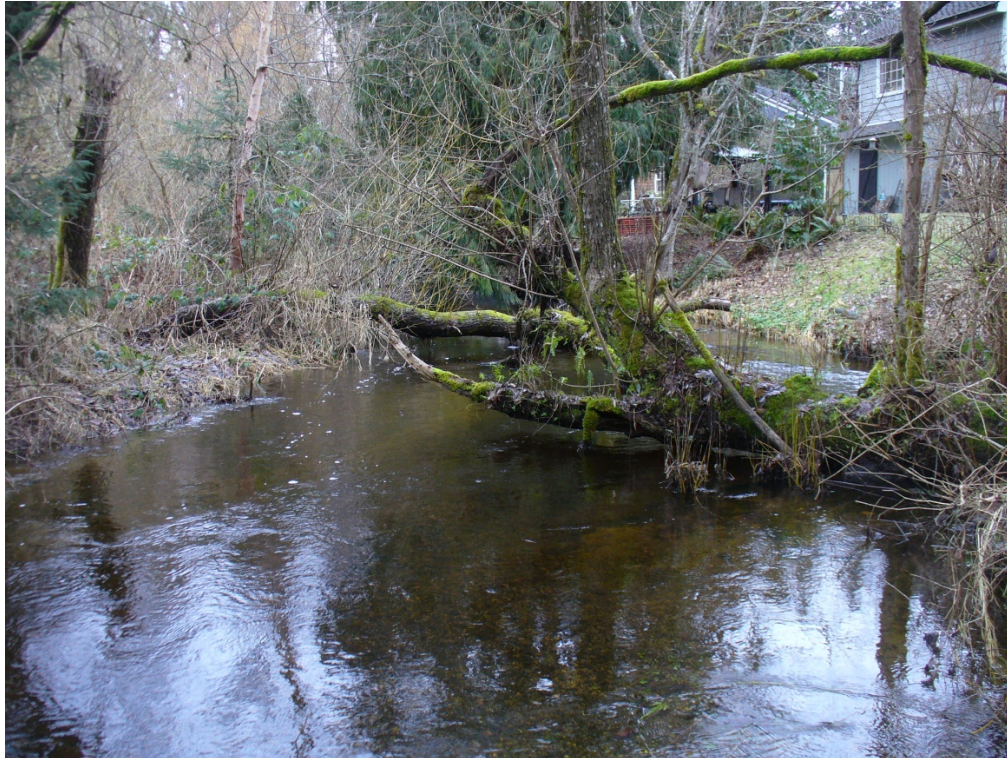
Figure 19. The channel is resuming more natural characteristics with distance upstream of the weir (1/17/23).

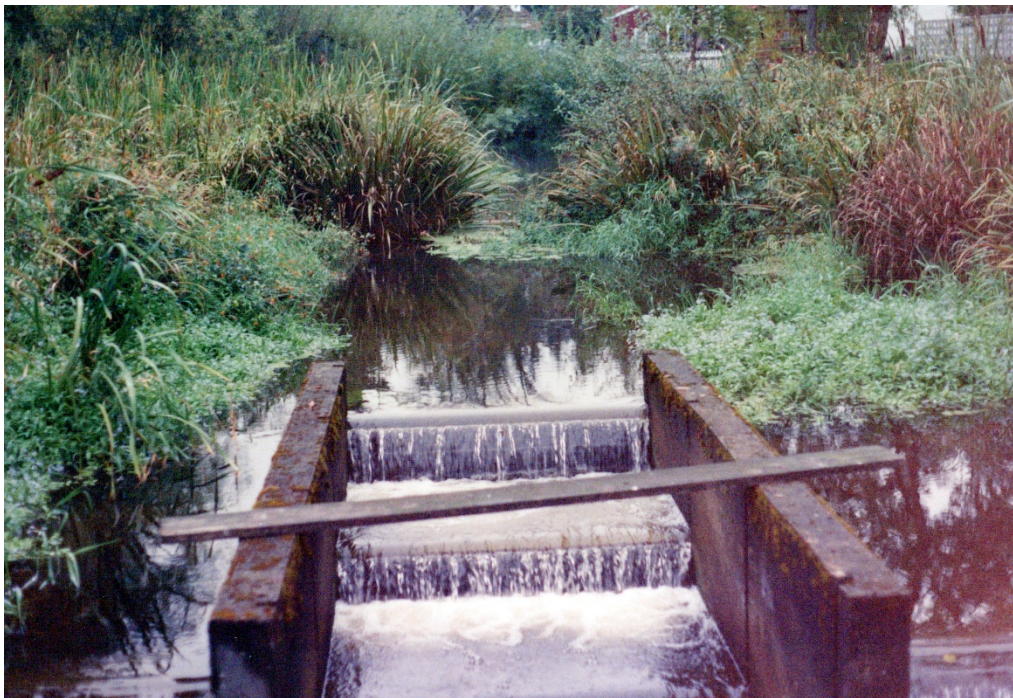
Figure 20. Fish ladder and area upstream in October of 1990 showing backwatered condition and emergent vegetation.

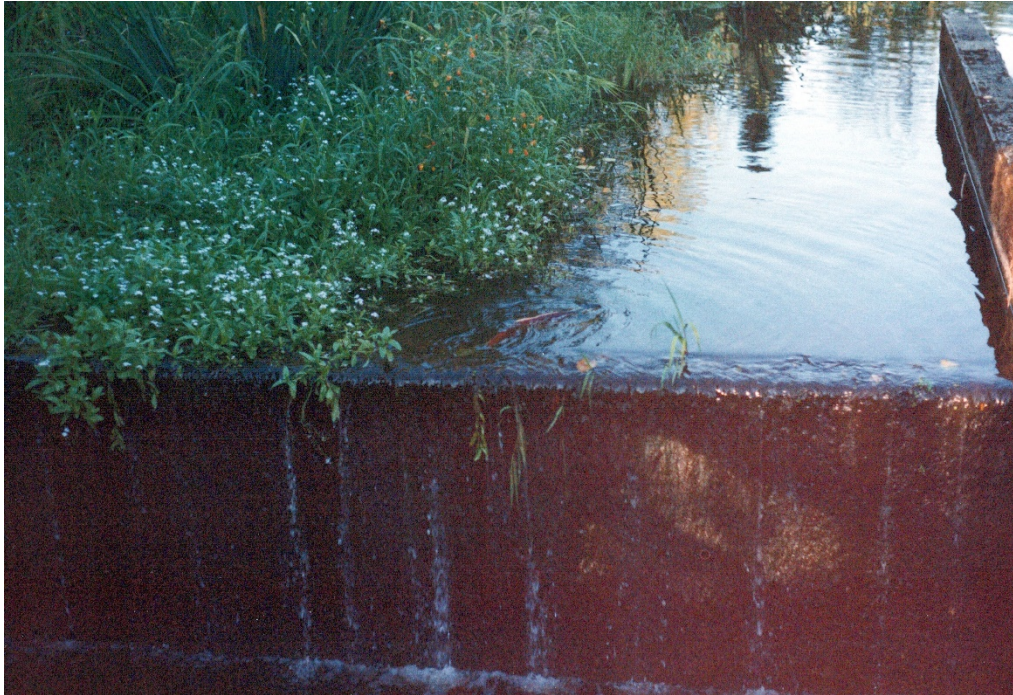
Figure 23. Water overflowing the dam and backwatering the channel upstream, October 1990.

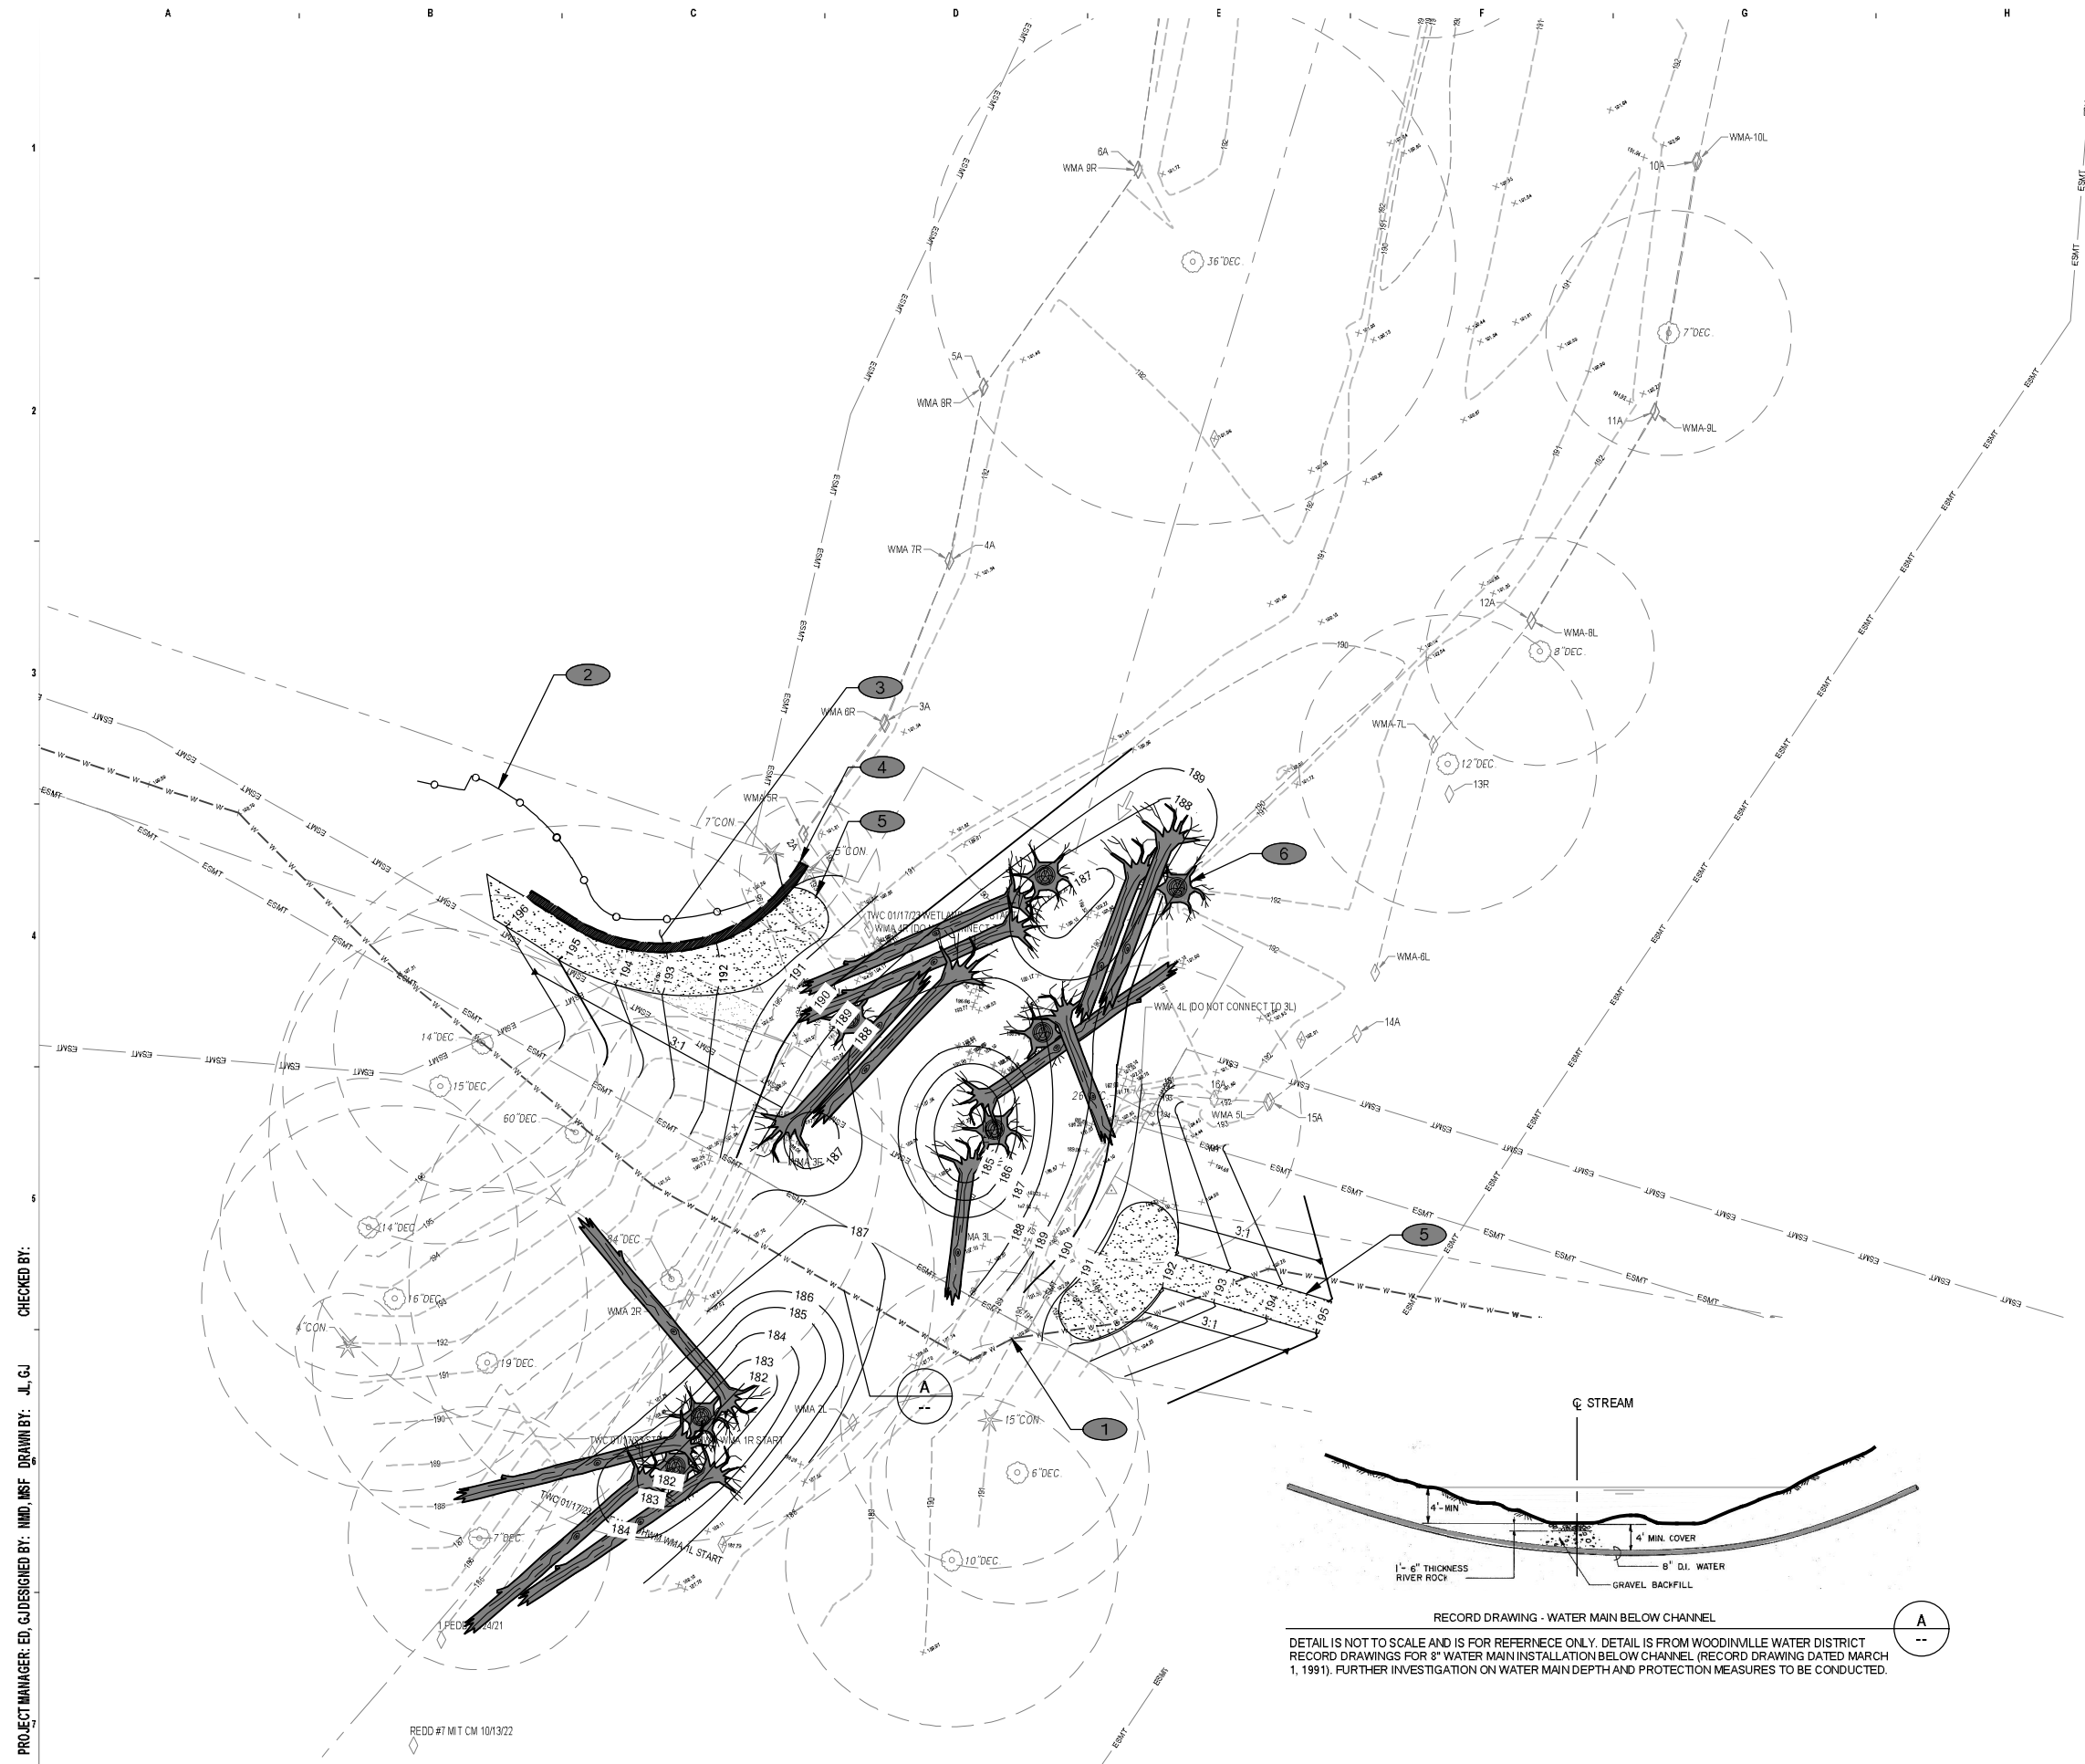
- ### KEY NOTES
- 1 PROTECT WATERMAIN DURING CONSTRUCTION (DEPTH IS APPROXIMATELY 4' BELOW CHANNEL PER AS-BUILT INFORMATION). PROJECT SEEKS TO MINIMIZE GROUND DISTURBANCE ABOVE PIPE AND AVOID FUTURE SCOUR. WATERMAIN RELOCATION MAY BE REQUIRED FOR FINISHED CONDITION (TBD).
 - 2 APPROXIMATE LOCATION OF EXISTING RESIDENTIAL BRICK WALL AND VEGETATION. ADDITIONAL SURVEY AND INVESTIGATION TO BE CONDUCTED TO DETERMINE LOCATION AND PROTECTION MEASURES.
 - 3 TOPOGRAPHY IN THIS AREA IS APPROXIMATE, ADDITIONAL SURVEY & INVESTIGATION AT PERMIT-LEVEL OR FINAL DESIGN.
 - 4 LANDSCAPE WALL, ADDITIONAL SURVEY AND INVESTIGATION TO BE CONDUCTED.
 - 5 PROPOSED TRAIL AND OVERLOOK, TYP. SEE PROPOSED SITE & RESTORATION PLAN.
 - 6 PRELIMINARY LARGE WOODY MATERIAL PLACEMENT (TYP).
